34. NOME - SOLOMONLocation

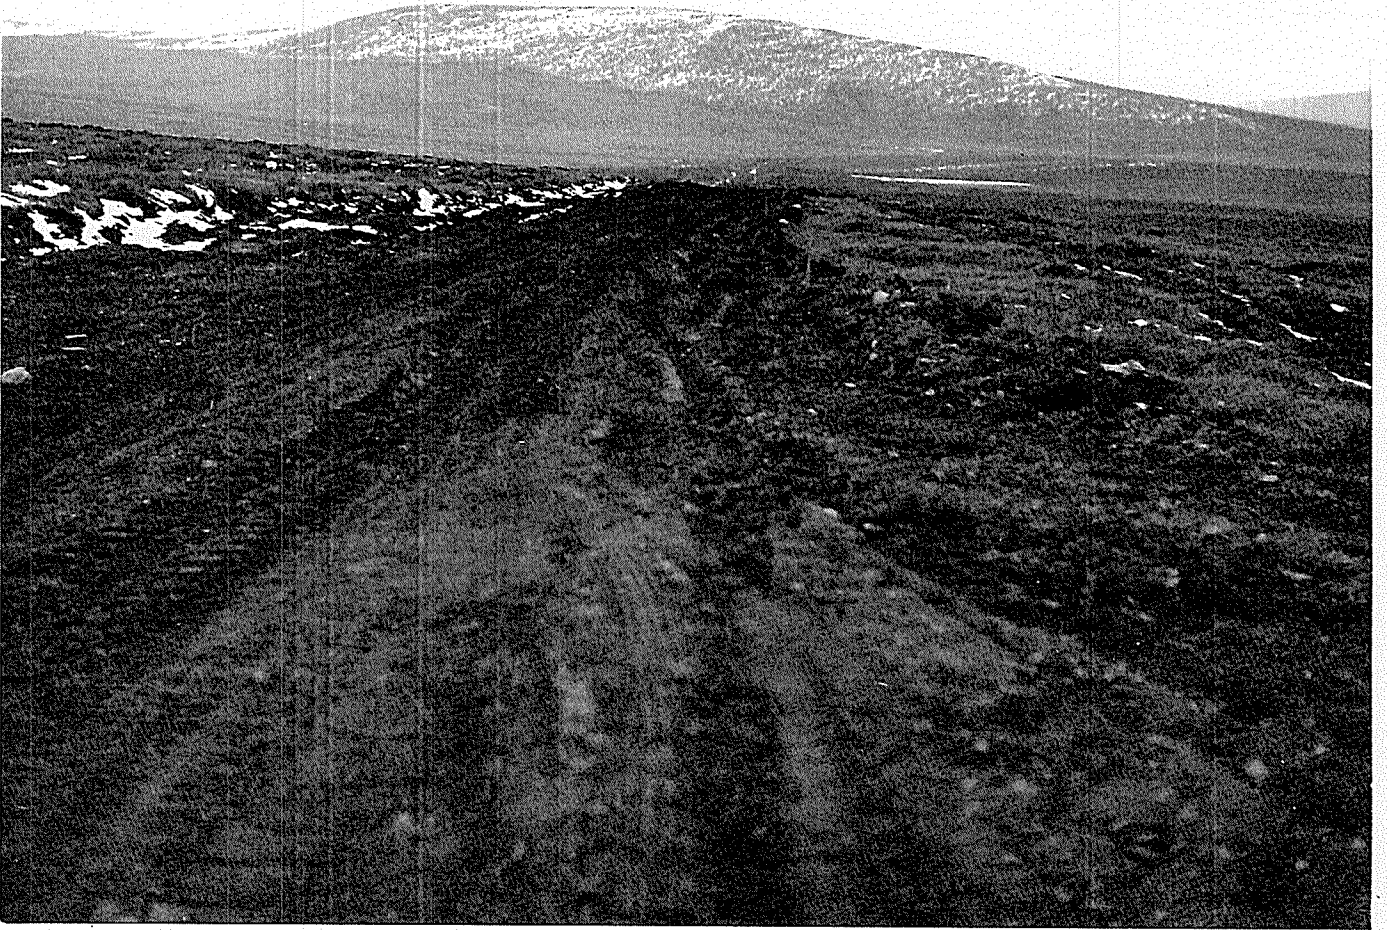
Fig. 31-11 SS 07 None; end of passable road this date. Subgrade built for additional 7 miles.

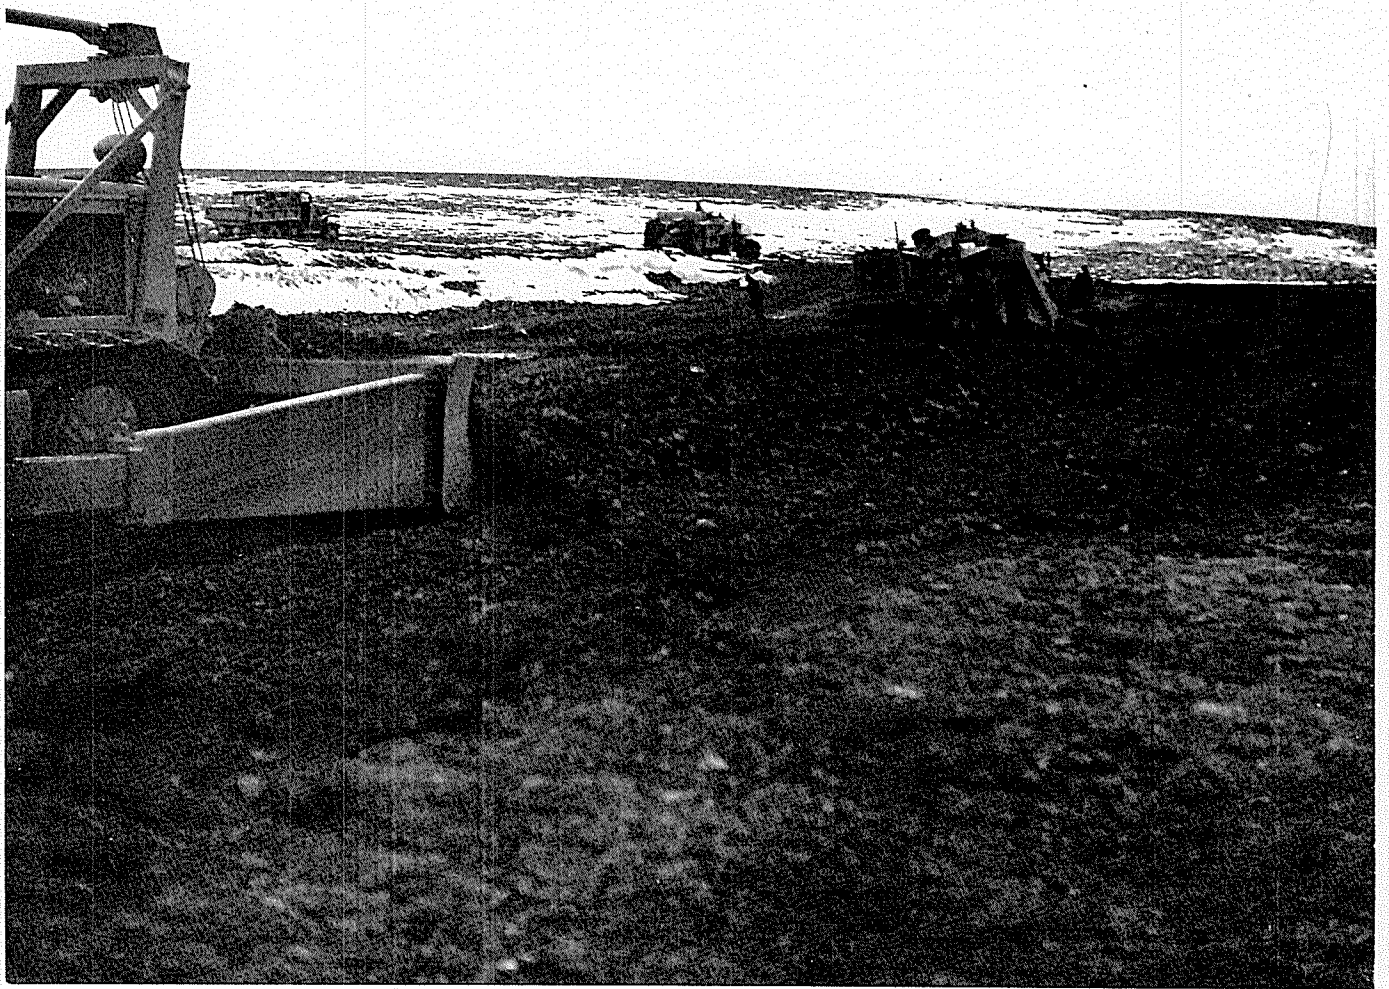
Fig. 33-D : US 97 Home; equipment working  
borrow pit.

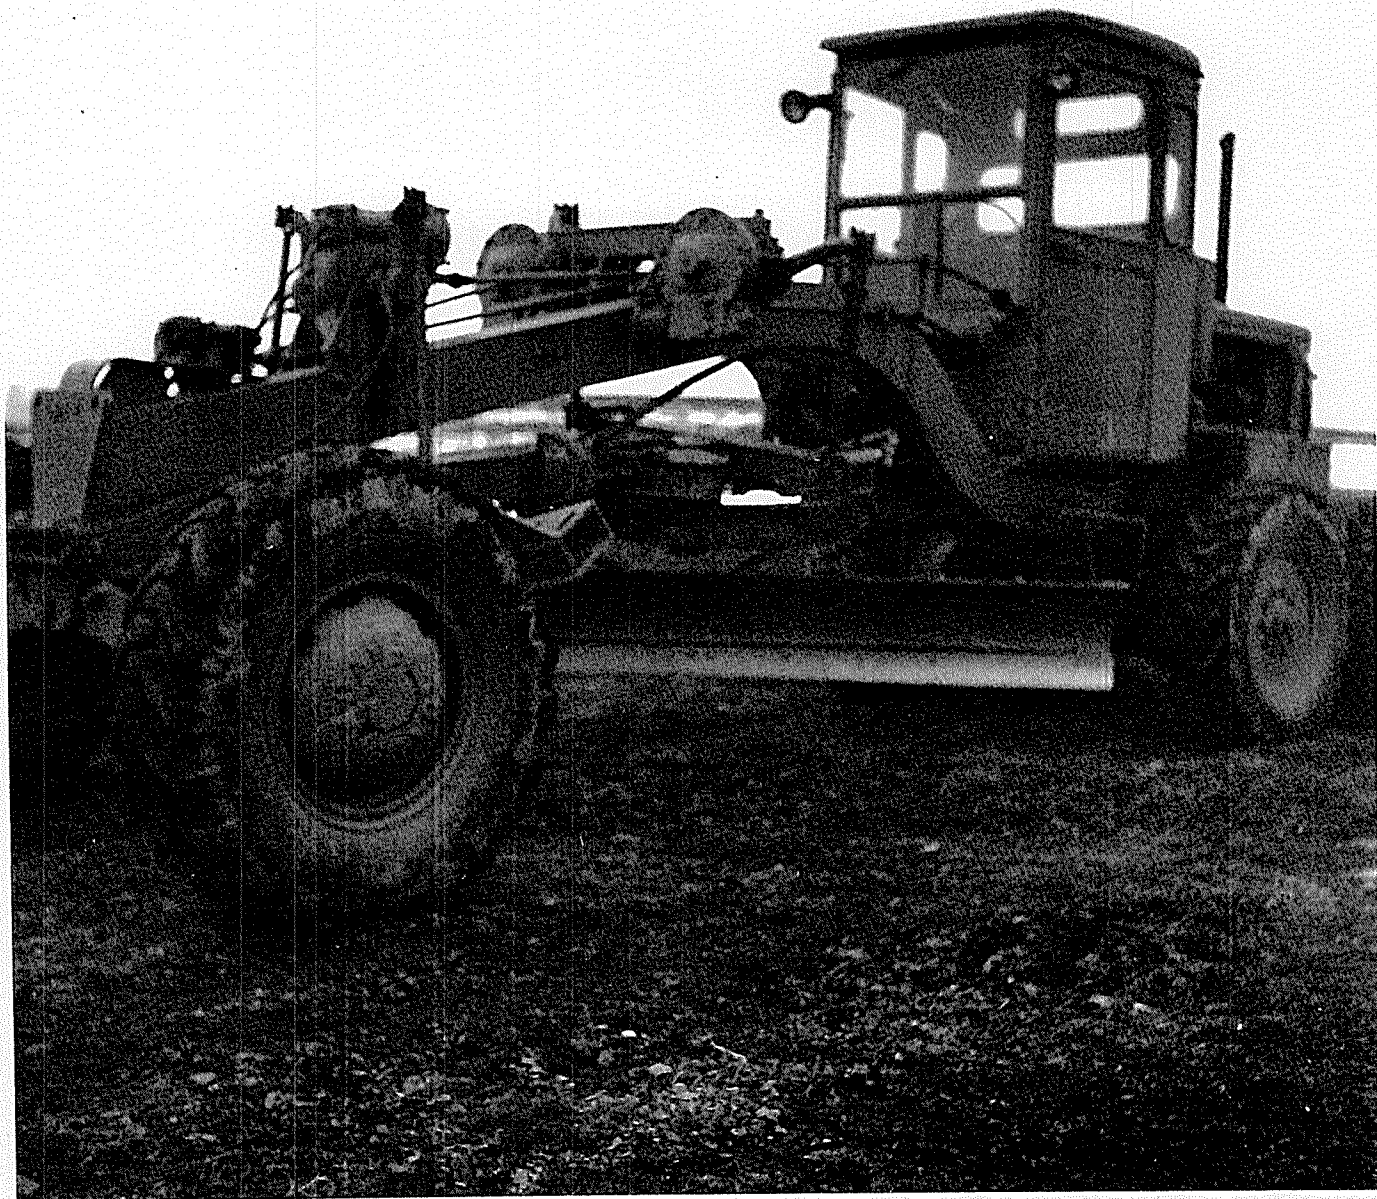
Fig. 33-B M3 67 1/2-ton - Adams motor patrol.

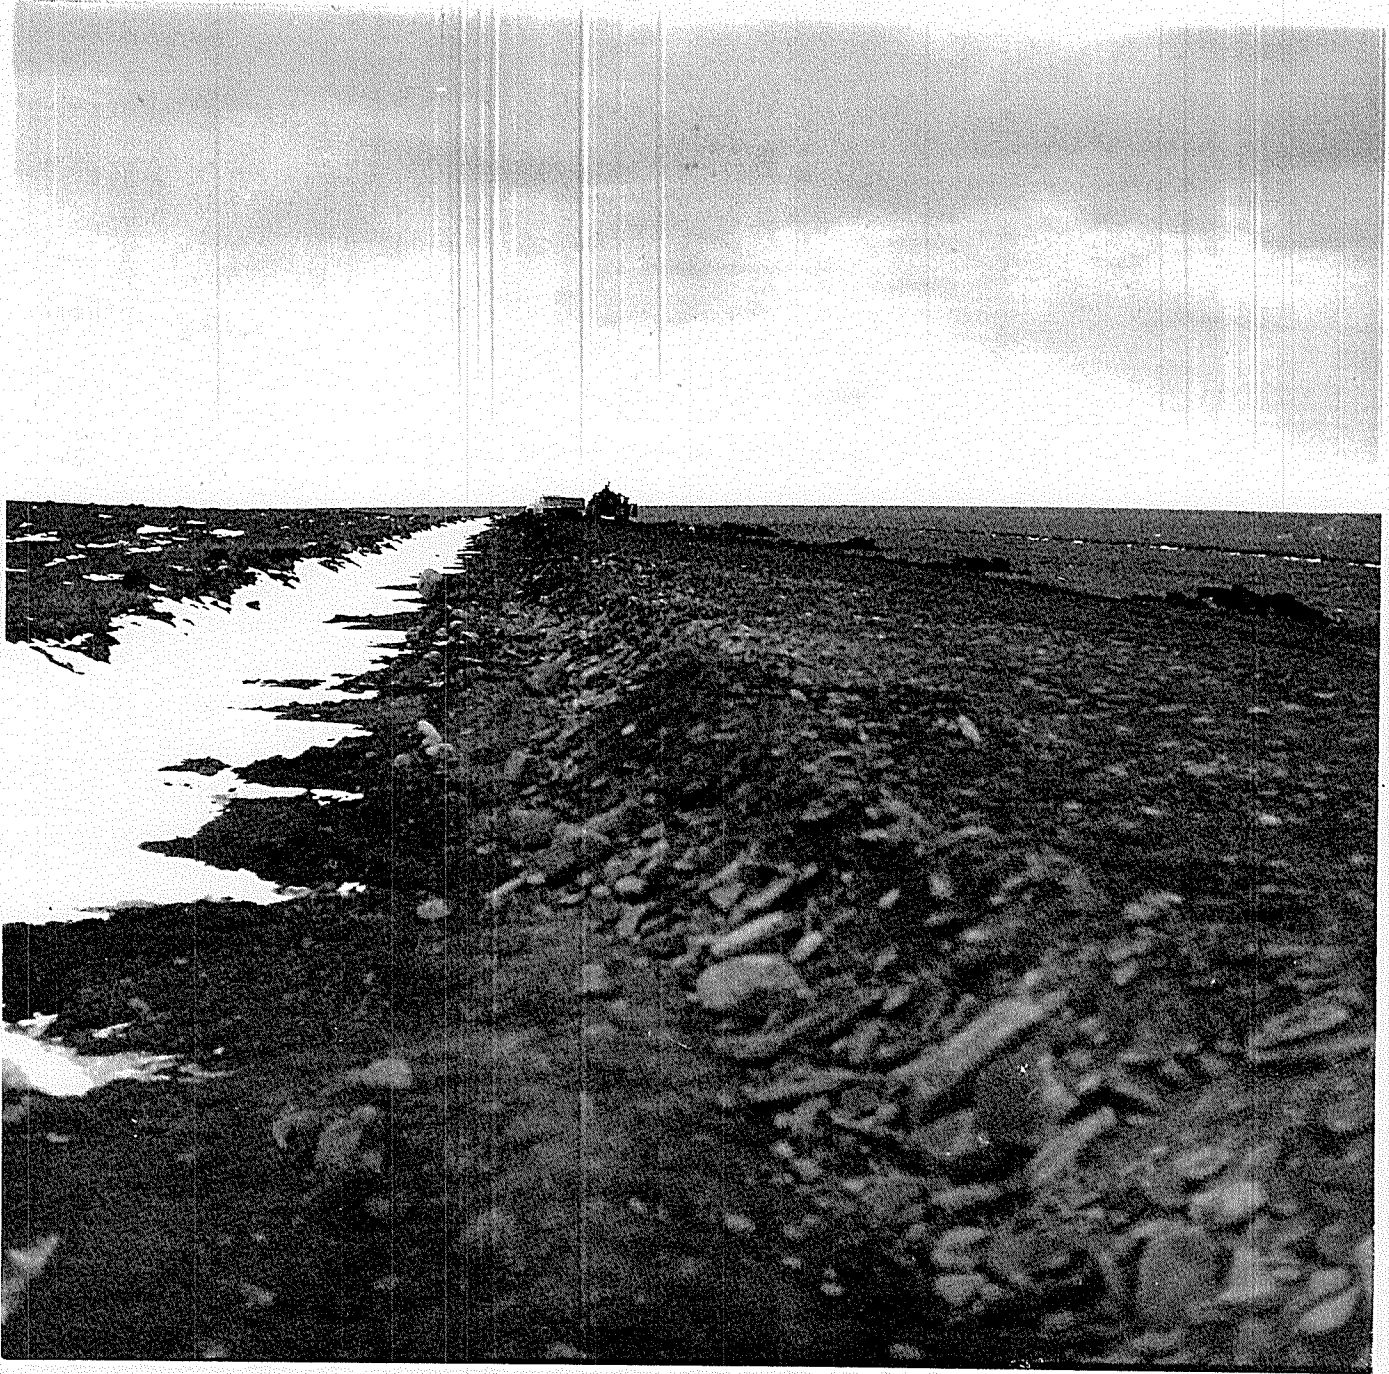
Fig. 33-P US 97 - Nons. Typical fill section placed by contractor.

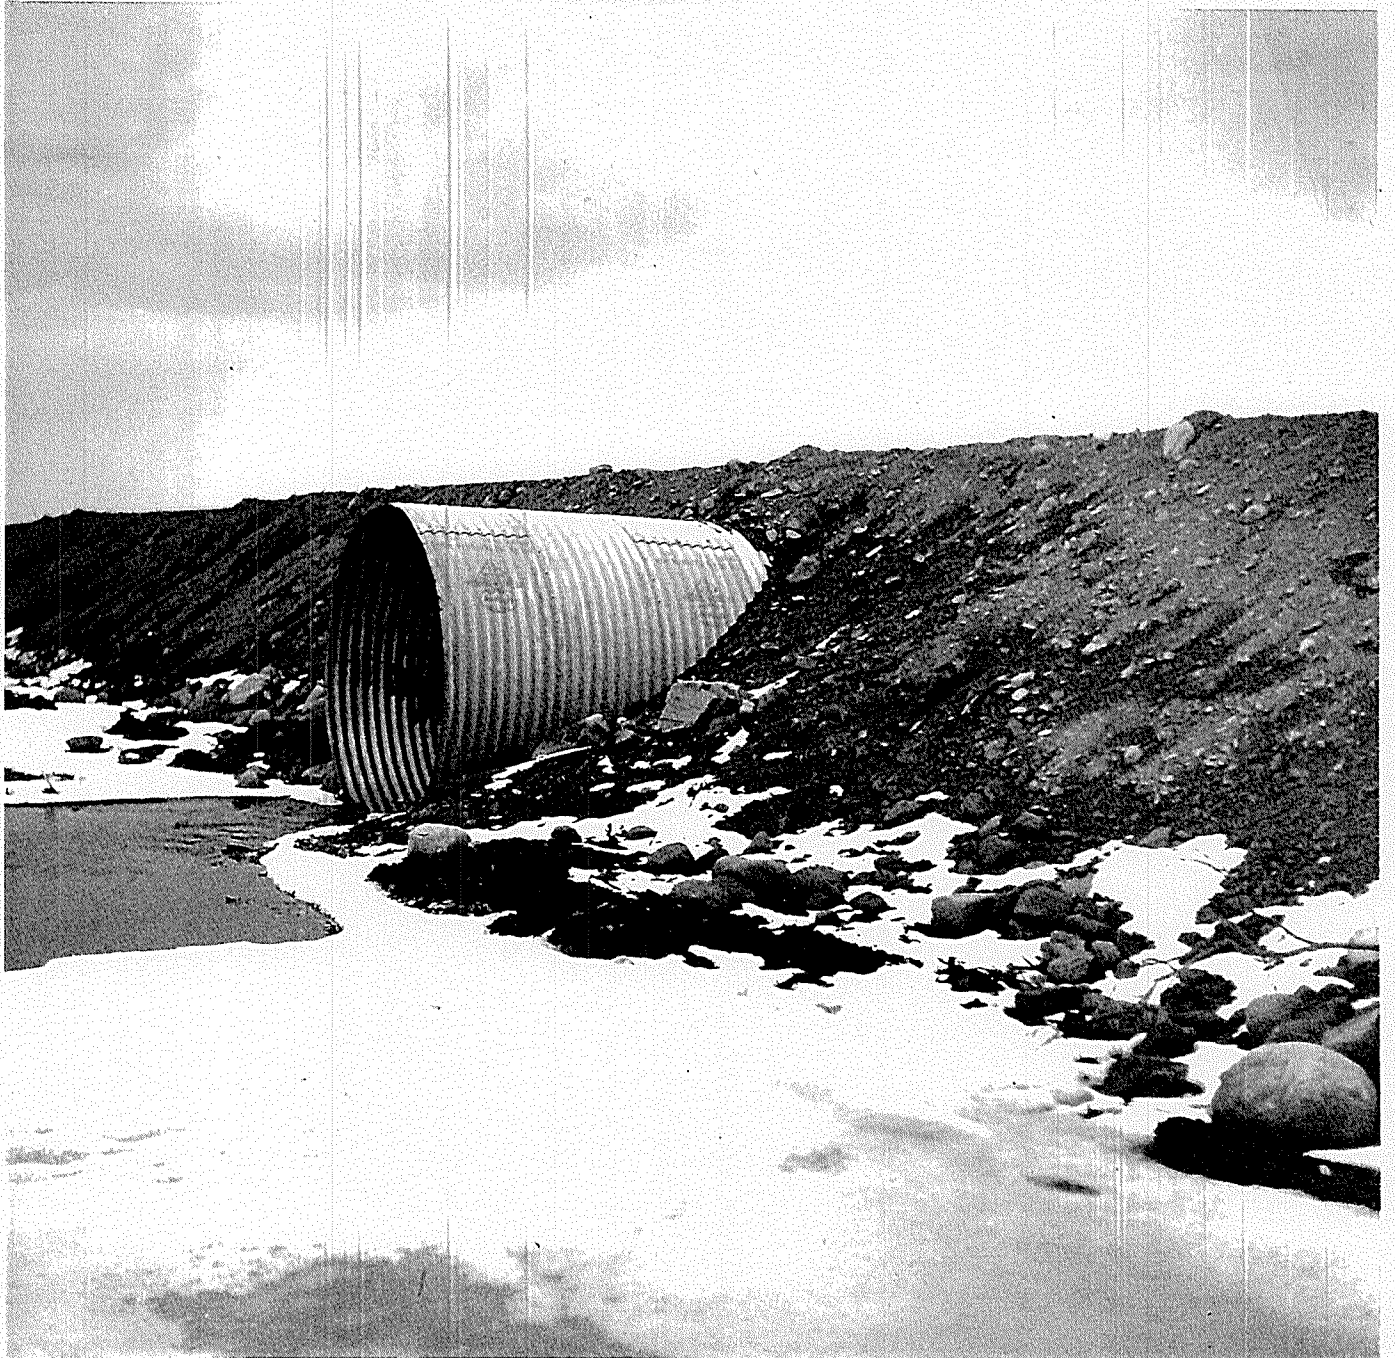
Fig. 33-4 US 97 Stone - 60-inch  
multi-plate CIP culvert.

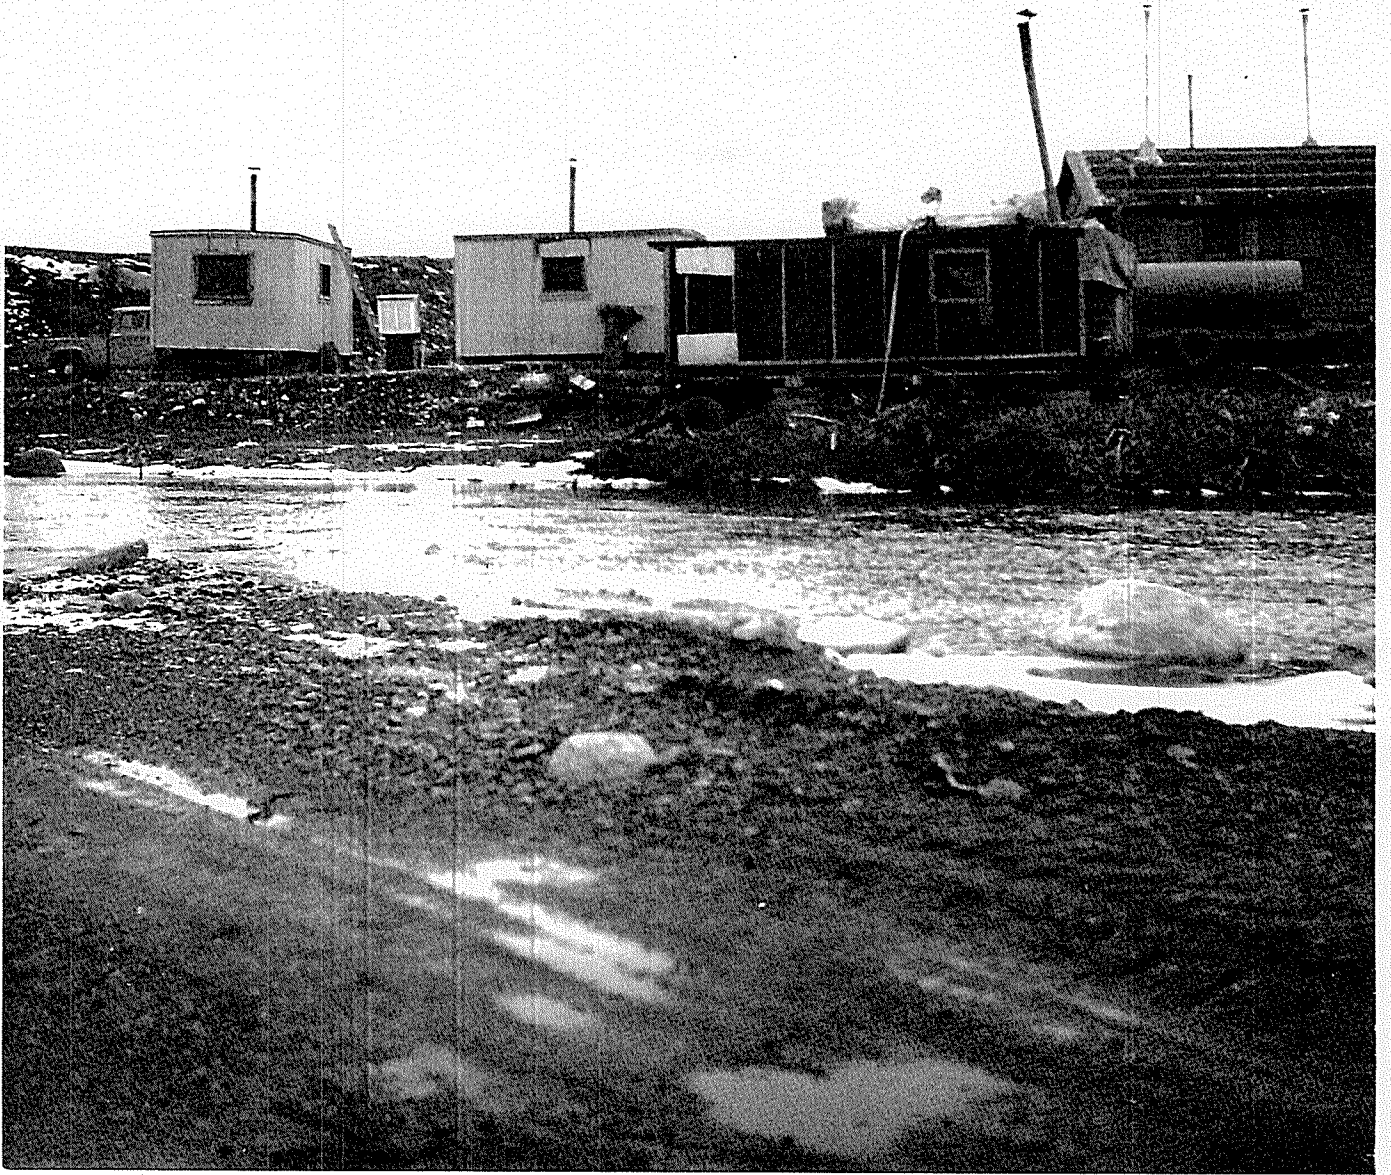
Fig. 35-II - US 97 team - Rear camp.  
at Center Creek.

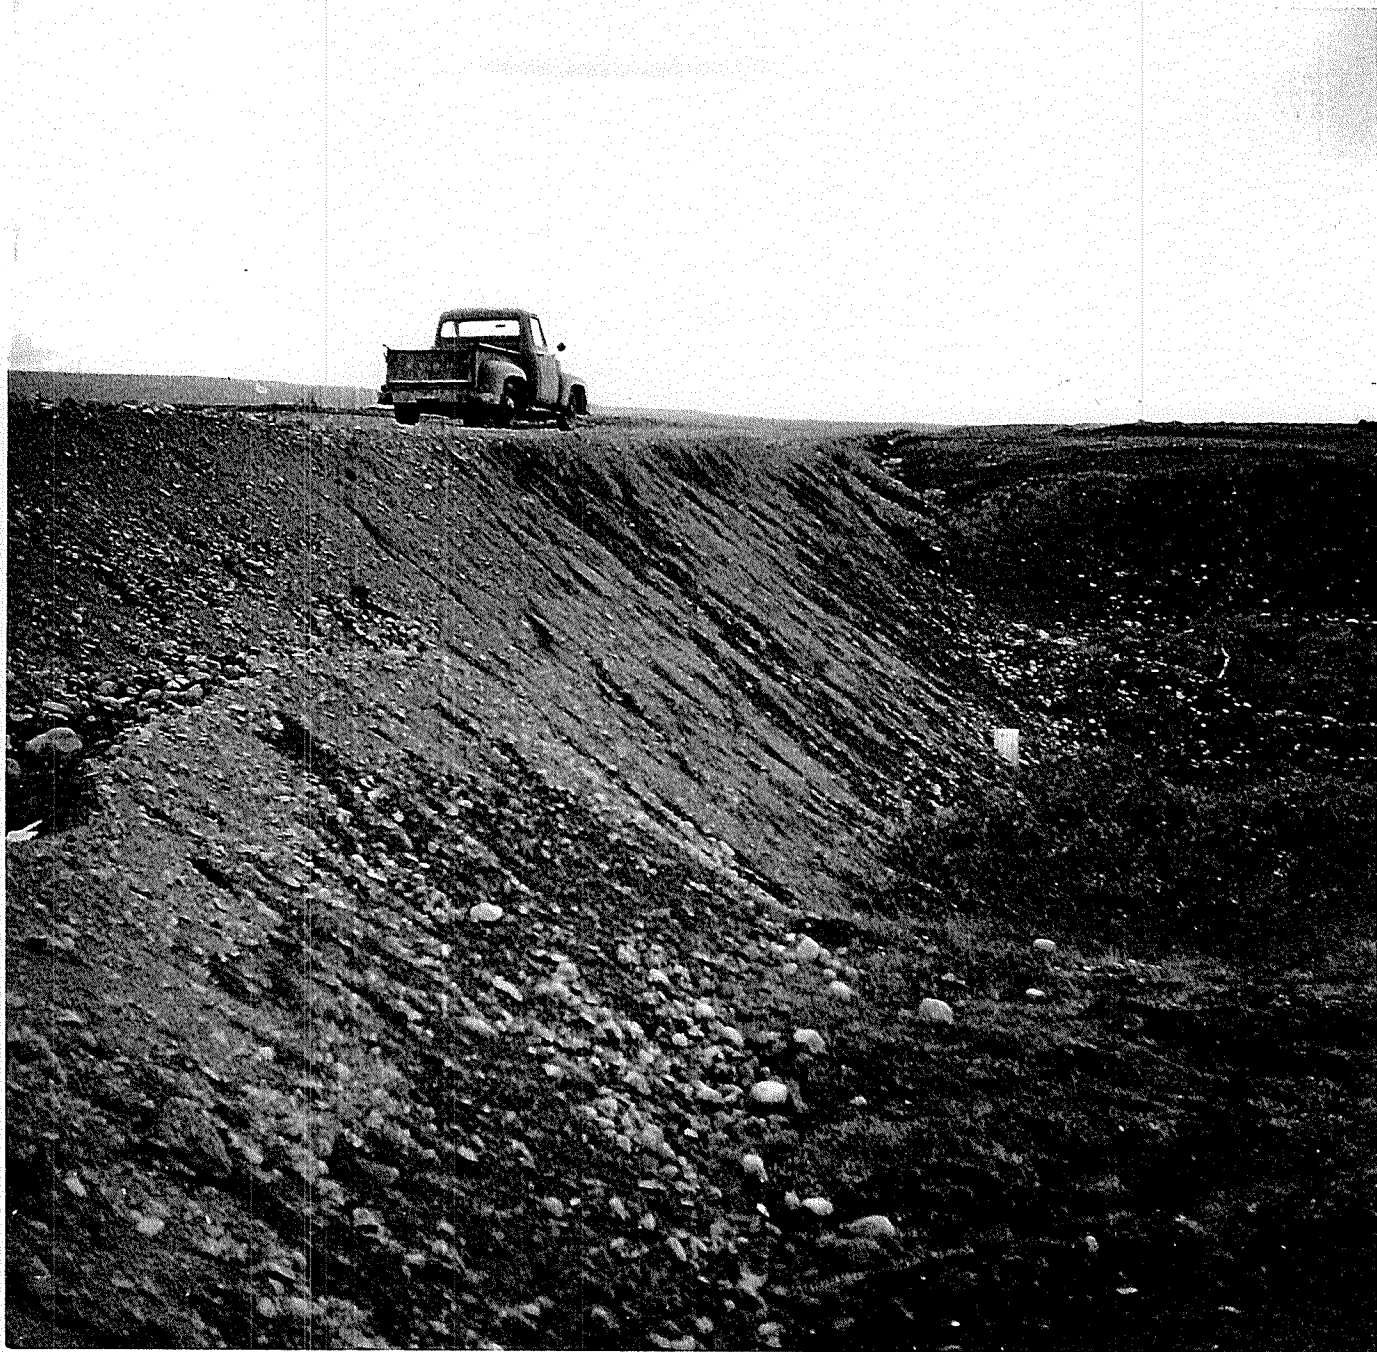
Fig. 33-1 US 07 1940 - maximum fill.

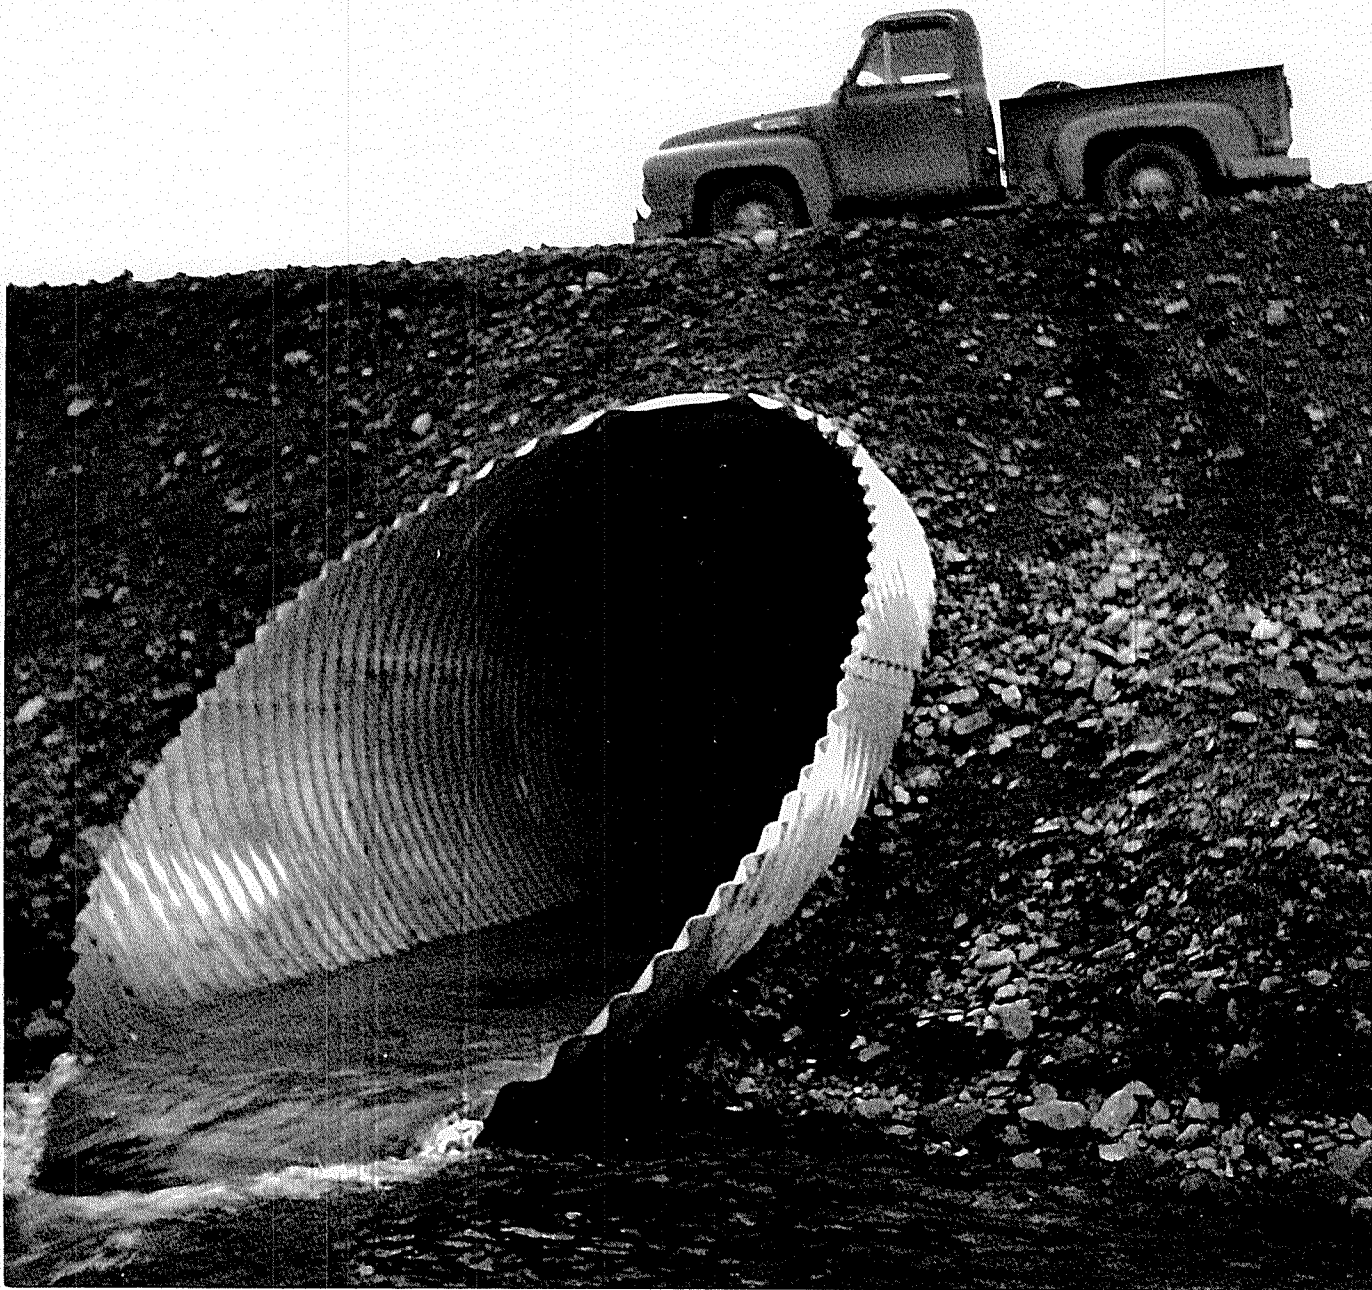
Fig. 33-J US 97 Home - 10-foot multi-plate CMP culvert.

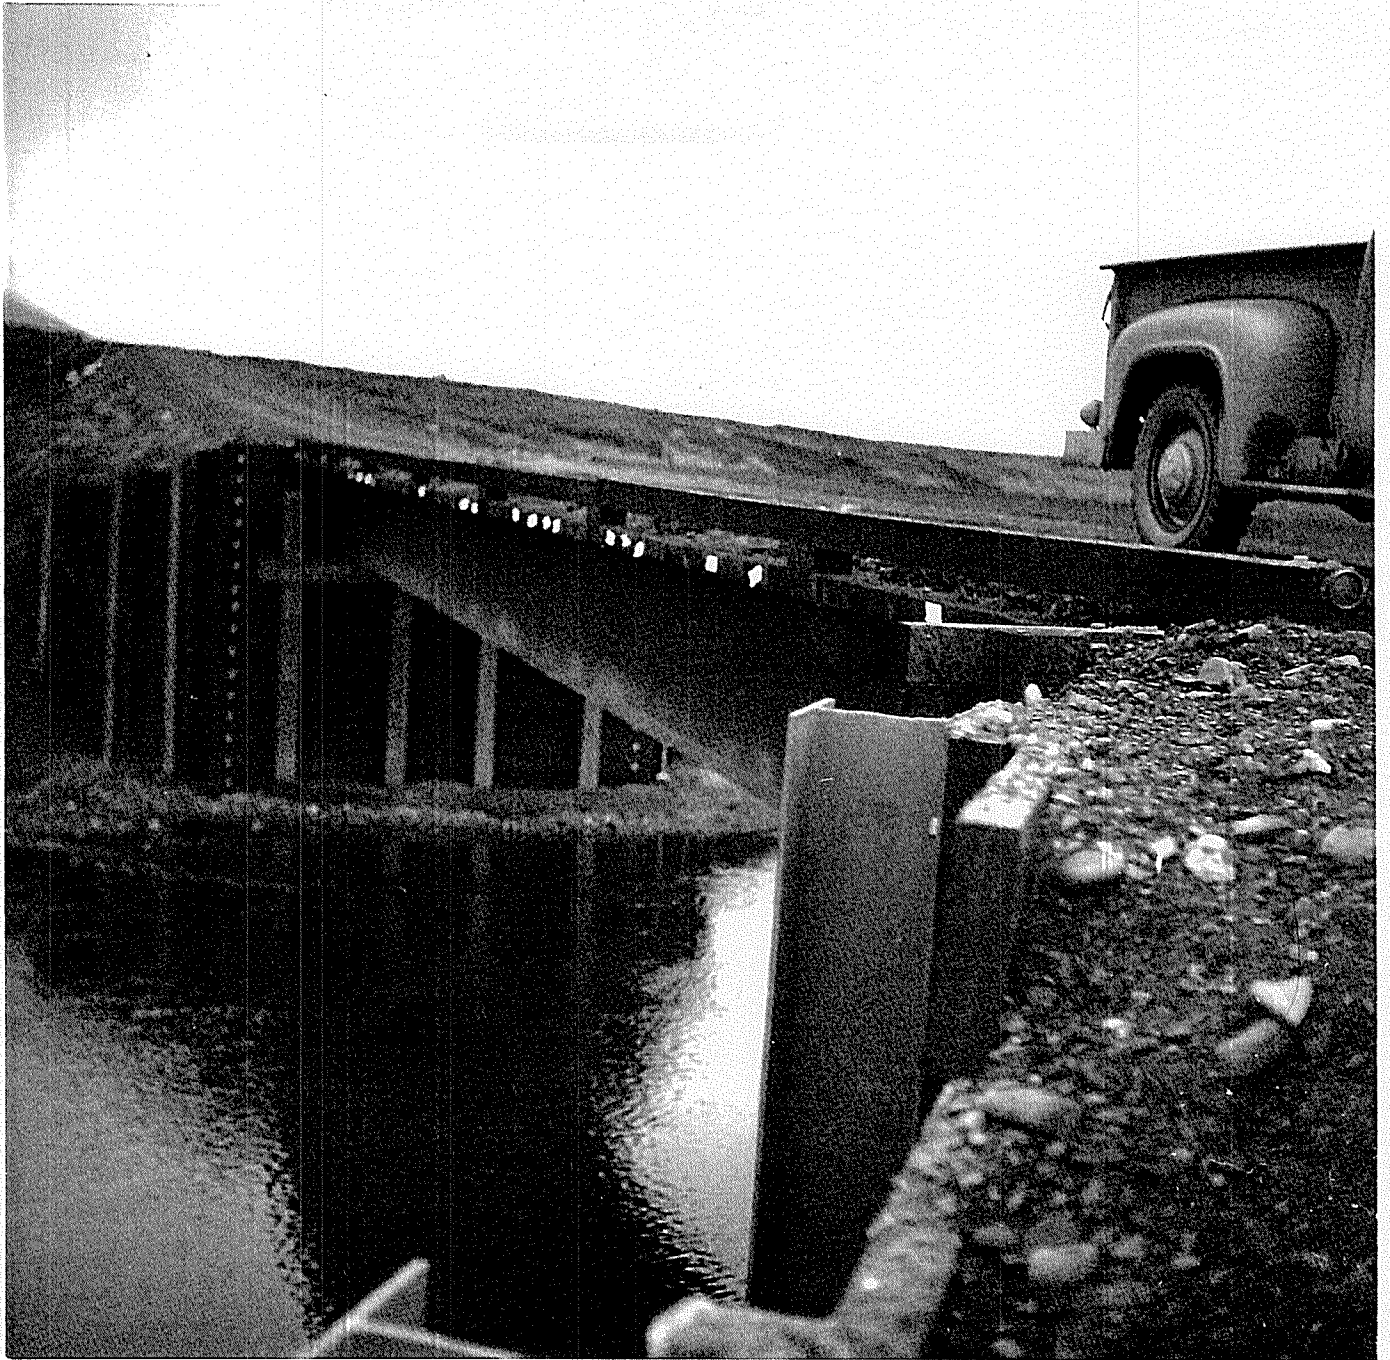
Fig. 33-1 US 97 News - Bridge over  
Grand Central River.

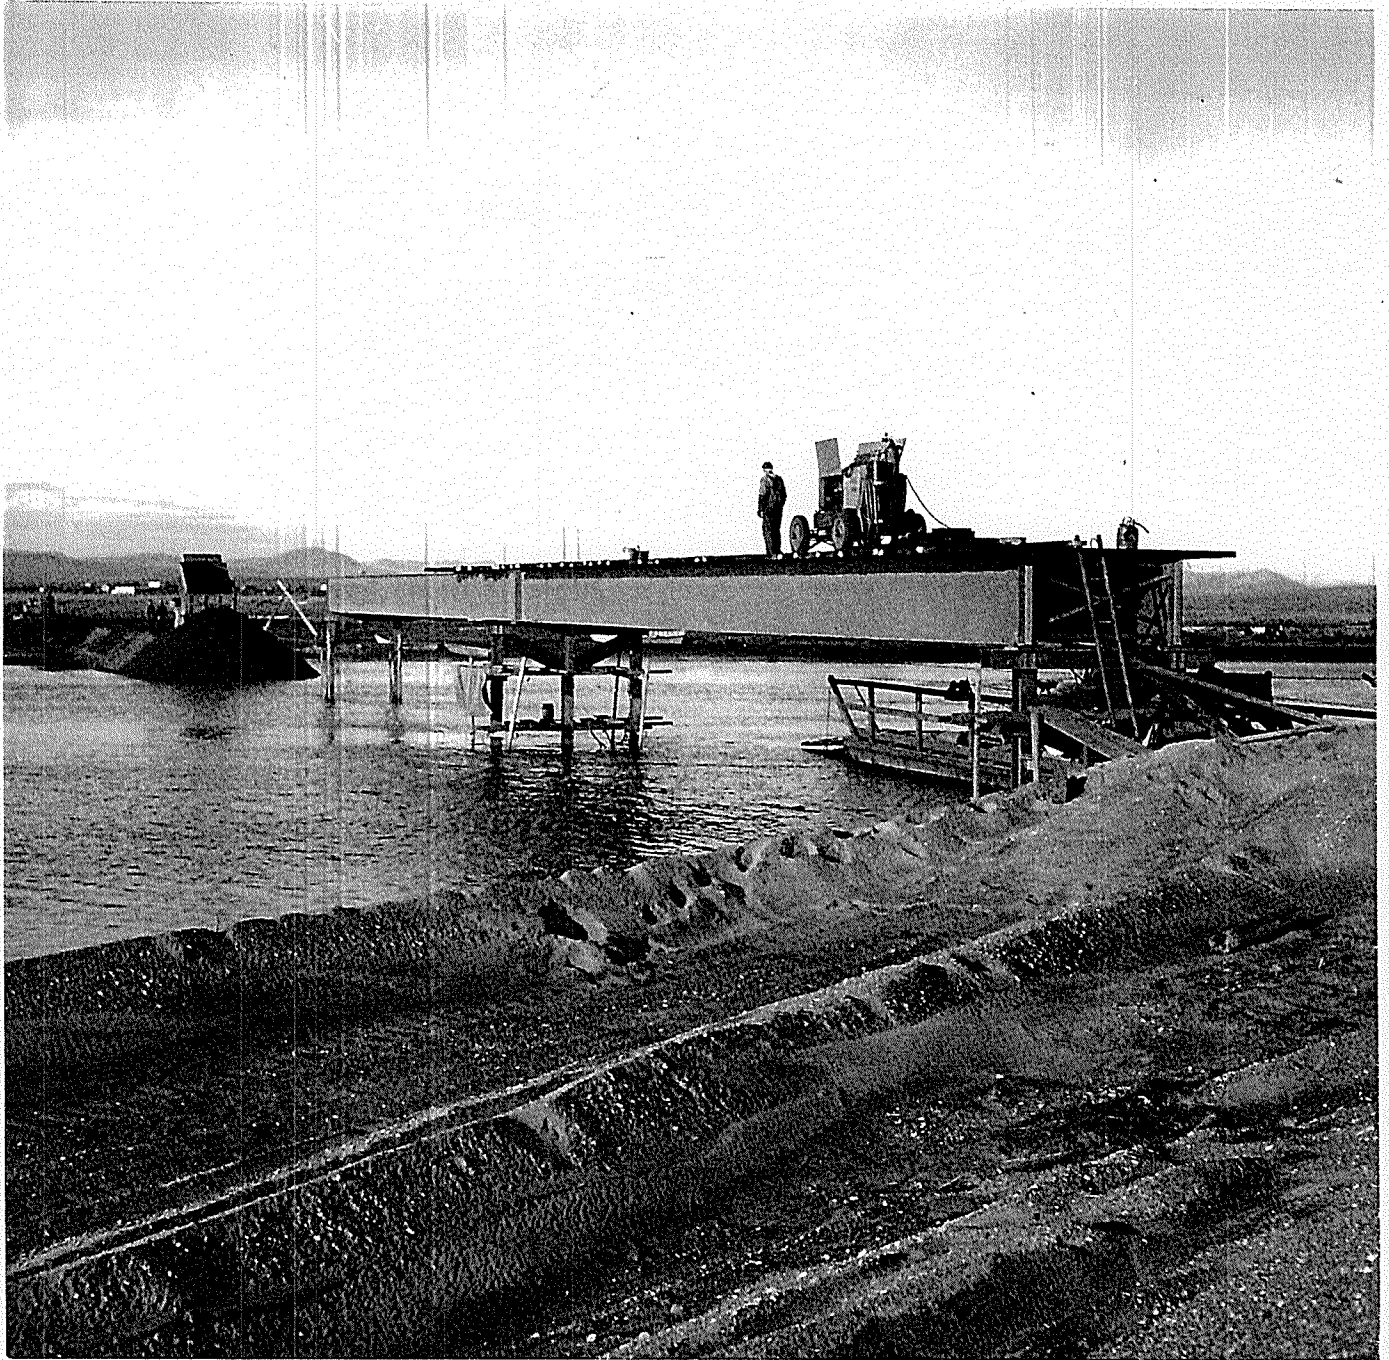
The bridge consists of a 2-span plate girder with a timber deck and approximately 300 feet of embankment at the north approach. The fill material was being hauled approximately 3.2 miles from a pit in the Solomon River.

The standards on this project are low. Much of the road will probably be lost during periods of high water, and it appears that the bridge should have an additional one or two spans for economic reasons, as well as maintenance. It further appears that the alignment and gradient of the road are dictated by the meandering of the river rather than any established standards.

**Fig. 34-A** **Ham-Solomon; bridge construction**  
**over ocean inlet near Dixon.**

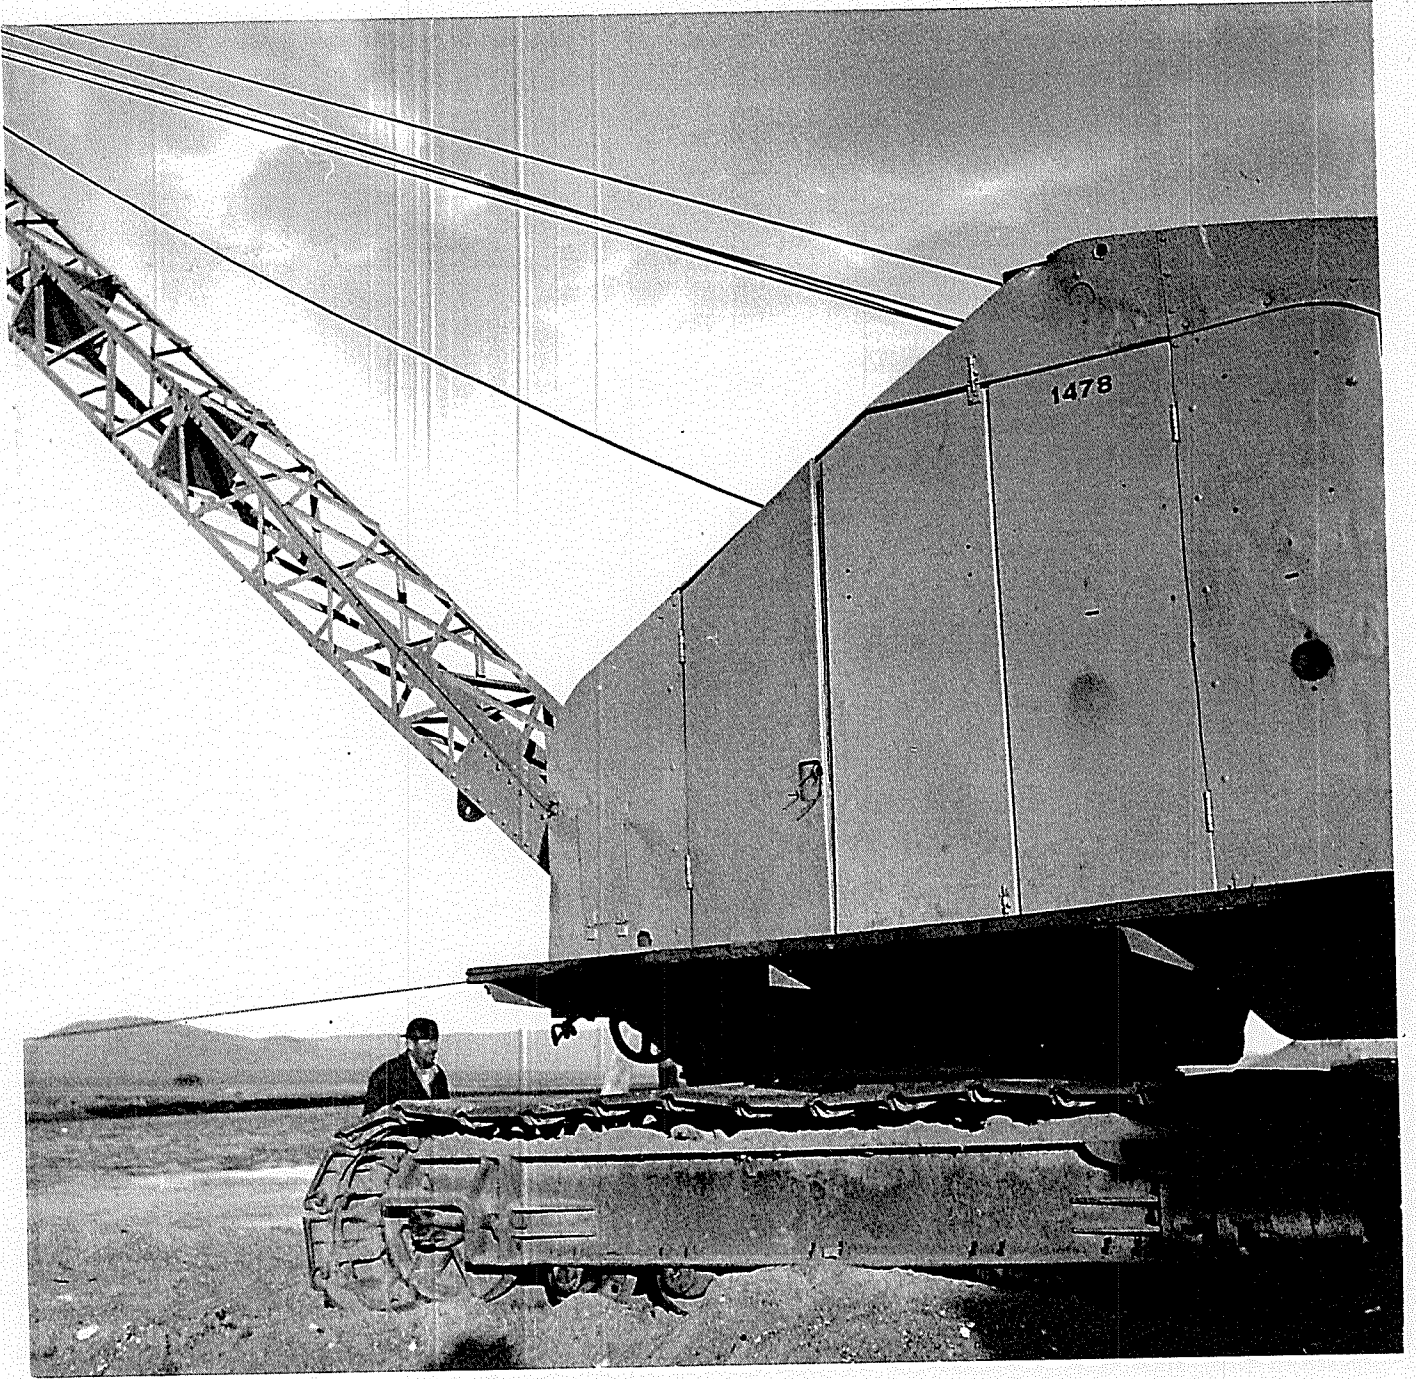
Plt. 34-B

Hono-Solomon; crane used for erecting plate girder bridge.

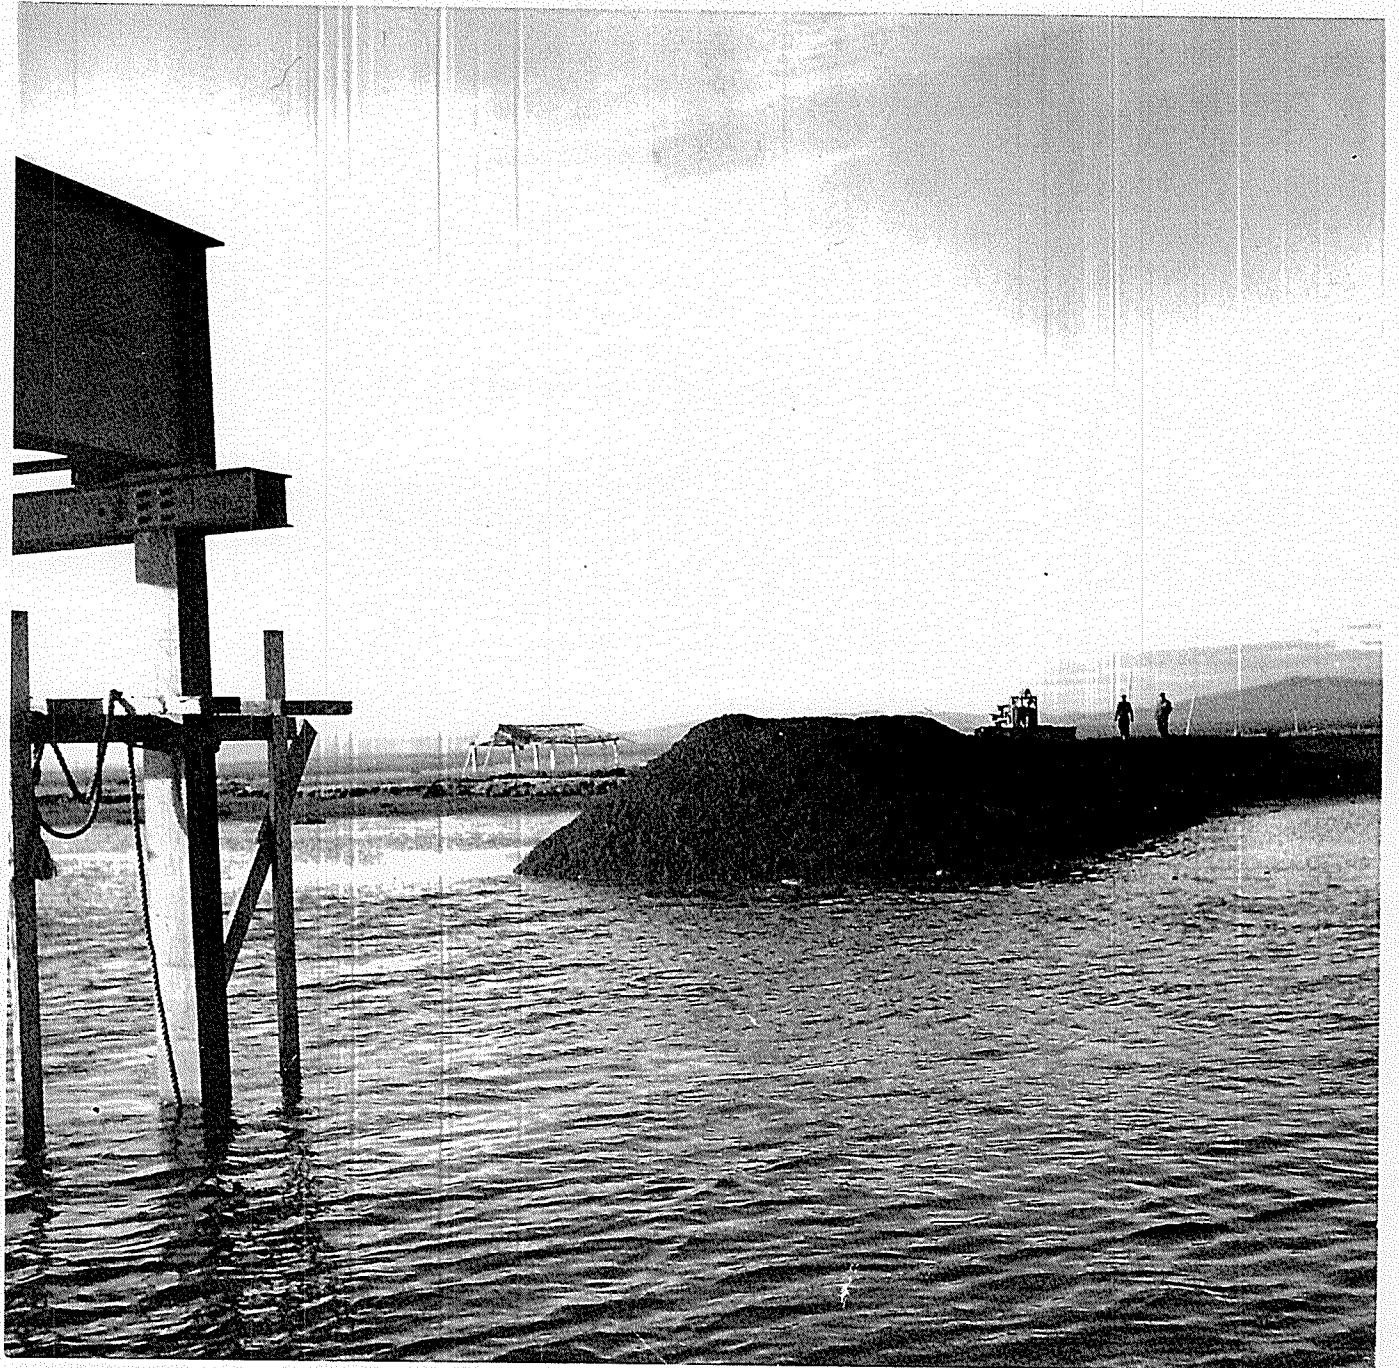
Fig. 34-C New-Solomon; long embankment construction at north bridge approach.
