MORTGAGE LOAN INSPECTION PLOT PLAN

07-099

LOT 13, U.S. SURVEY NO. 3208, ALASKA

MORTGAGEE: Mt. McKinley Mutual Savings Bank
MORTGAGOR OR OWNER: Casey & Janelle McCrackin

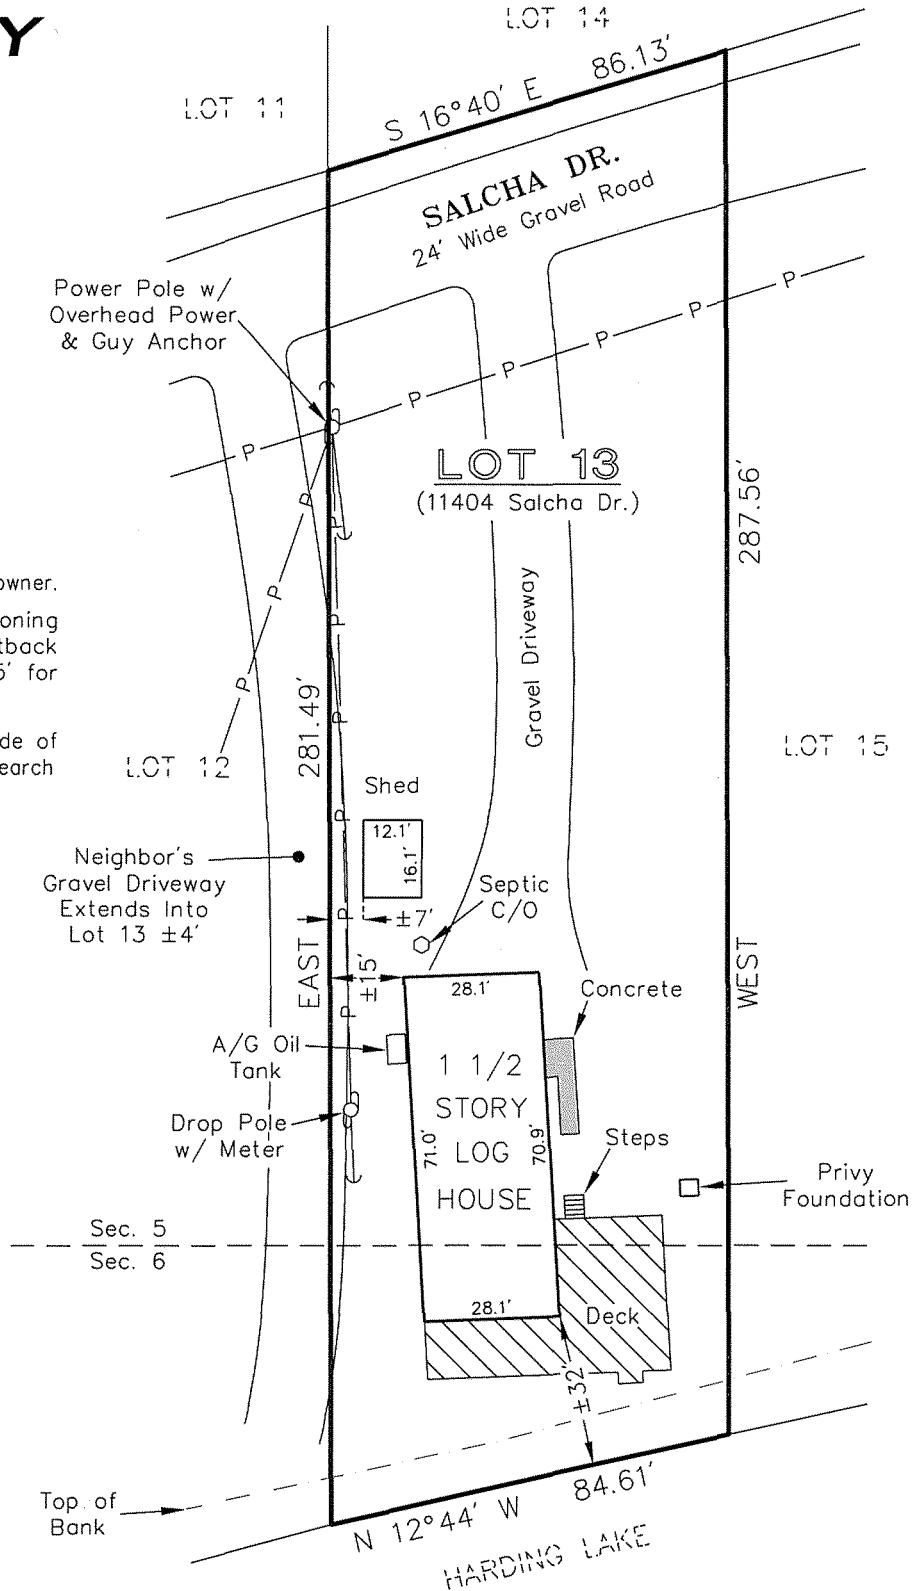
1. Water holding tank is inside house, as per owner.
2. Current Fairbanks North Star Borough zoning for this property is SF-10. Building setback requirements are 20' for front yards, 5' for side yards, and 10' for rear yards.
3. A 100' section line easement, 50' each side of the section line shown, may exist. This research was not performed for this survey.
