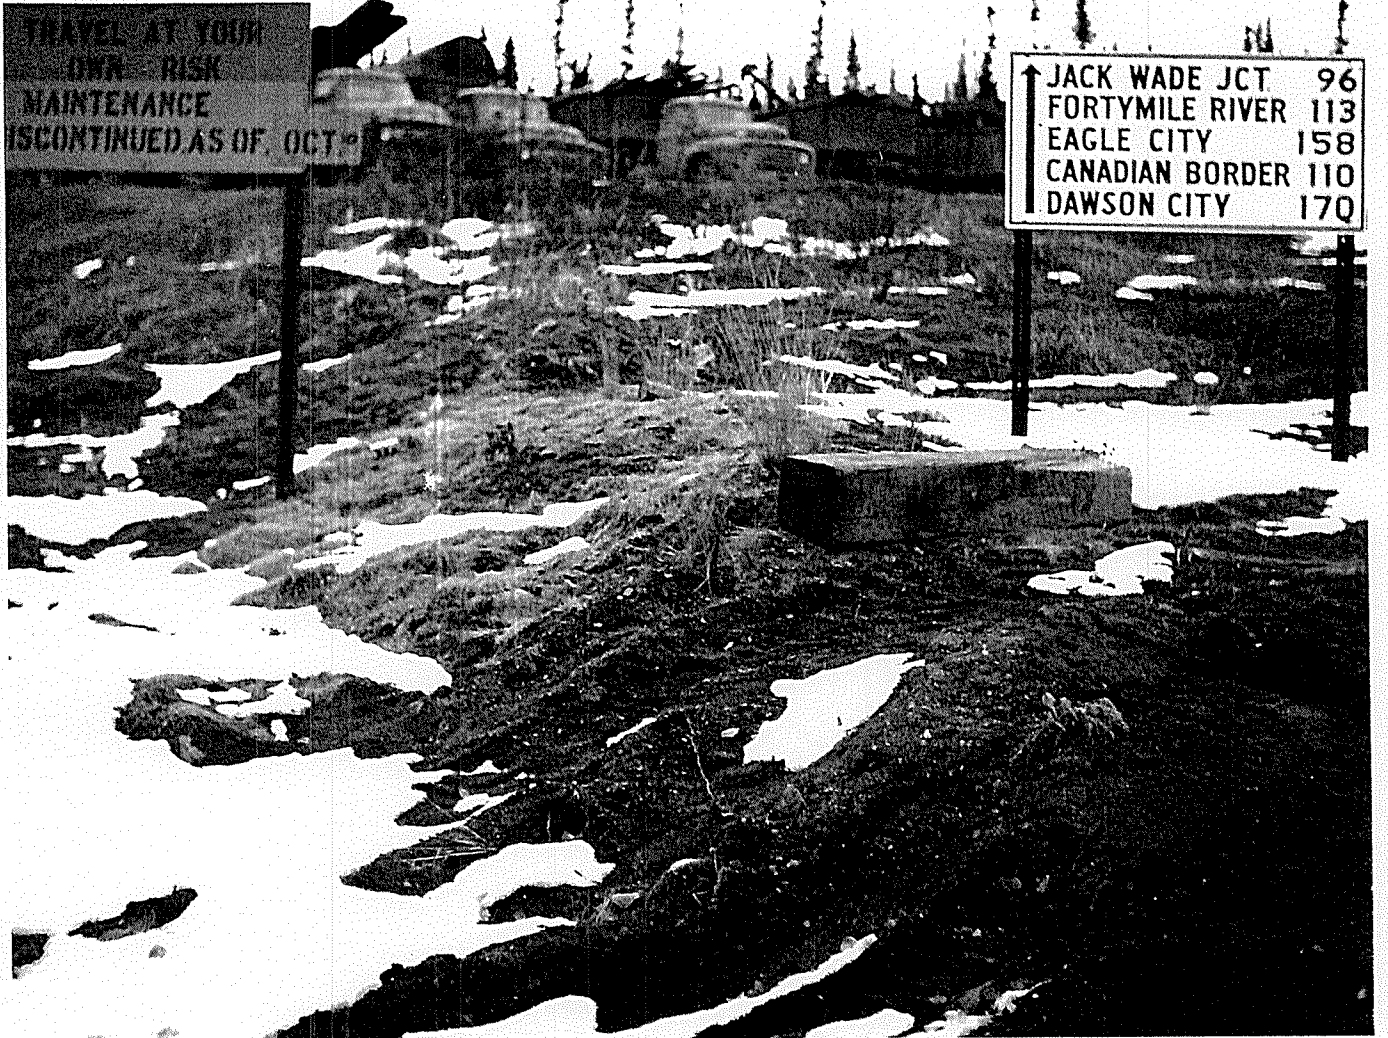
Fig. 6-4 Taylor Highway-Eagle South.
Junction of Taylor Highway and
Alaska Highway.

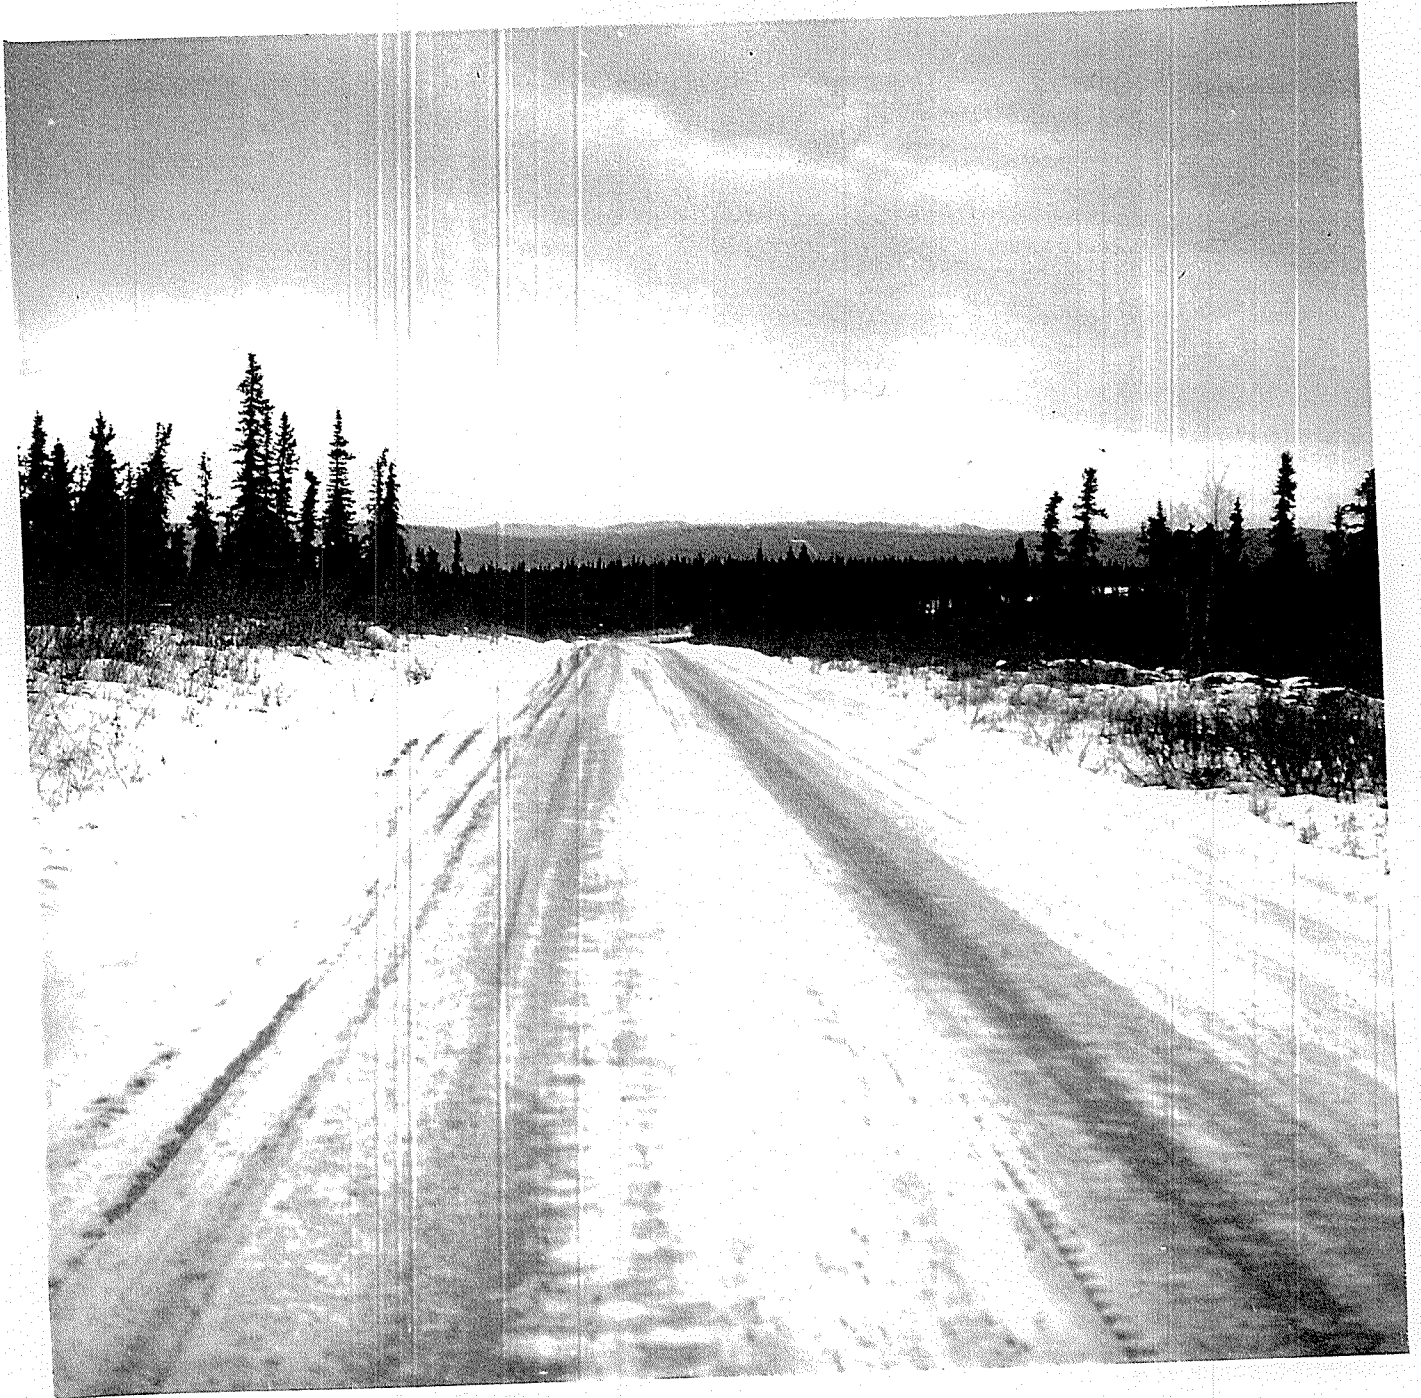
Fig. 9-1 Taylor Highway - Eagle South
Taylor Highway 20 miles from
south end.

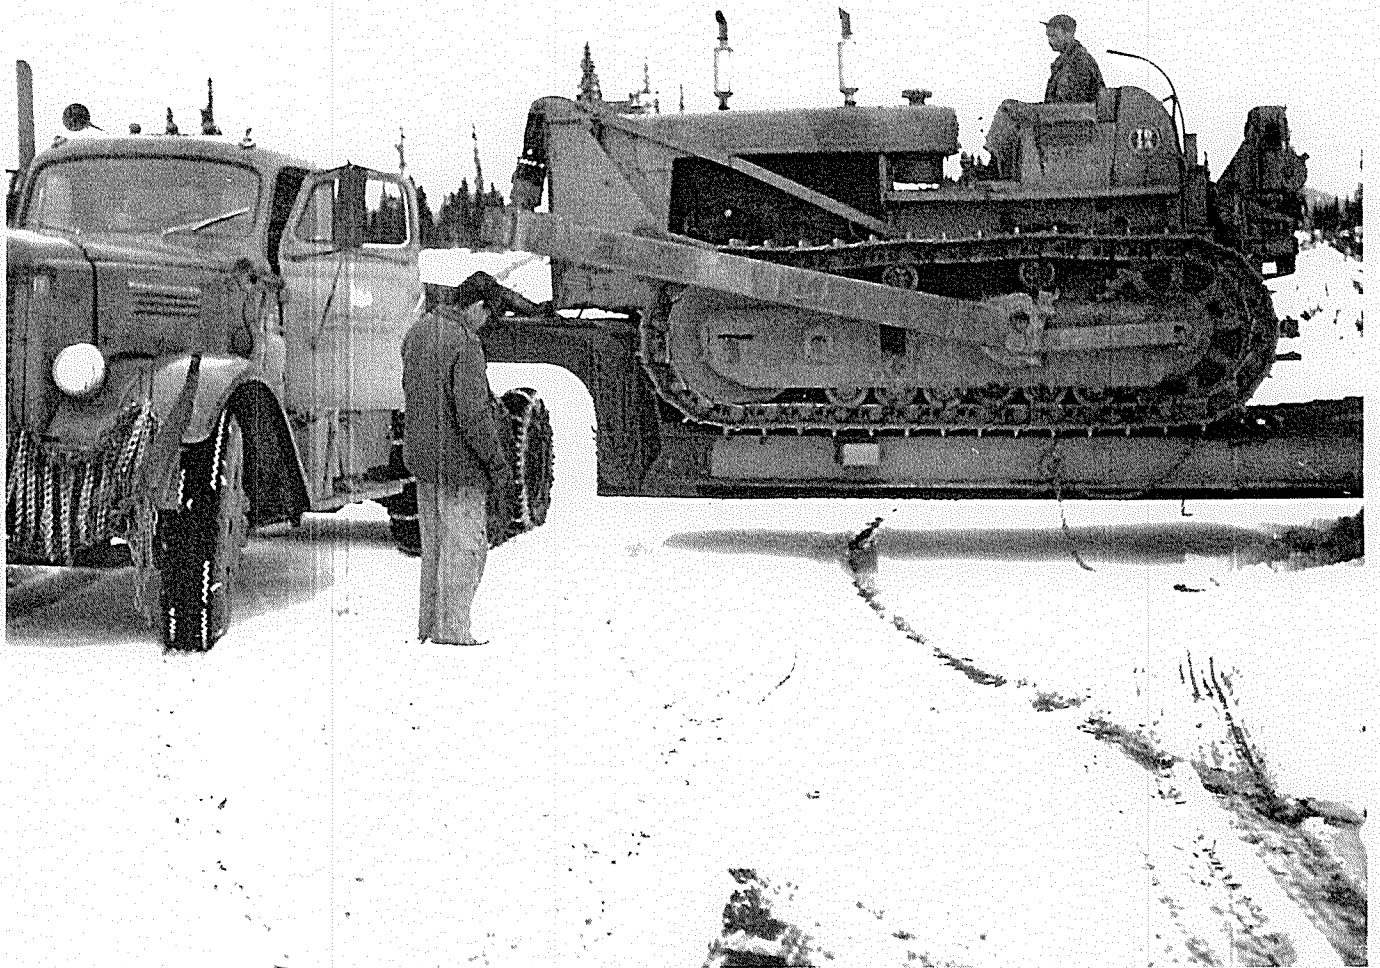
**Fig. 6-6 Taylor Highway - Eagle South
Loading out T1-E3.**

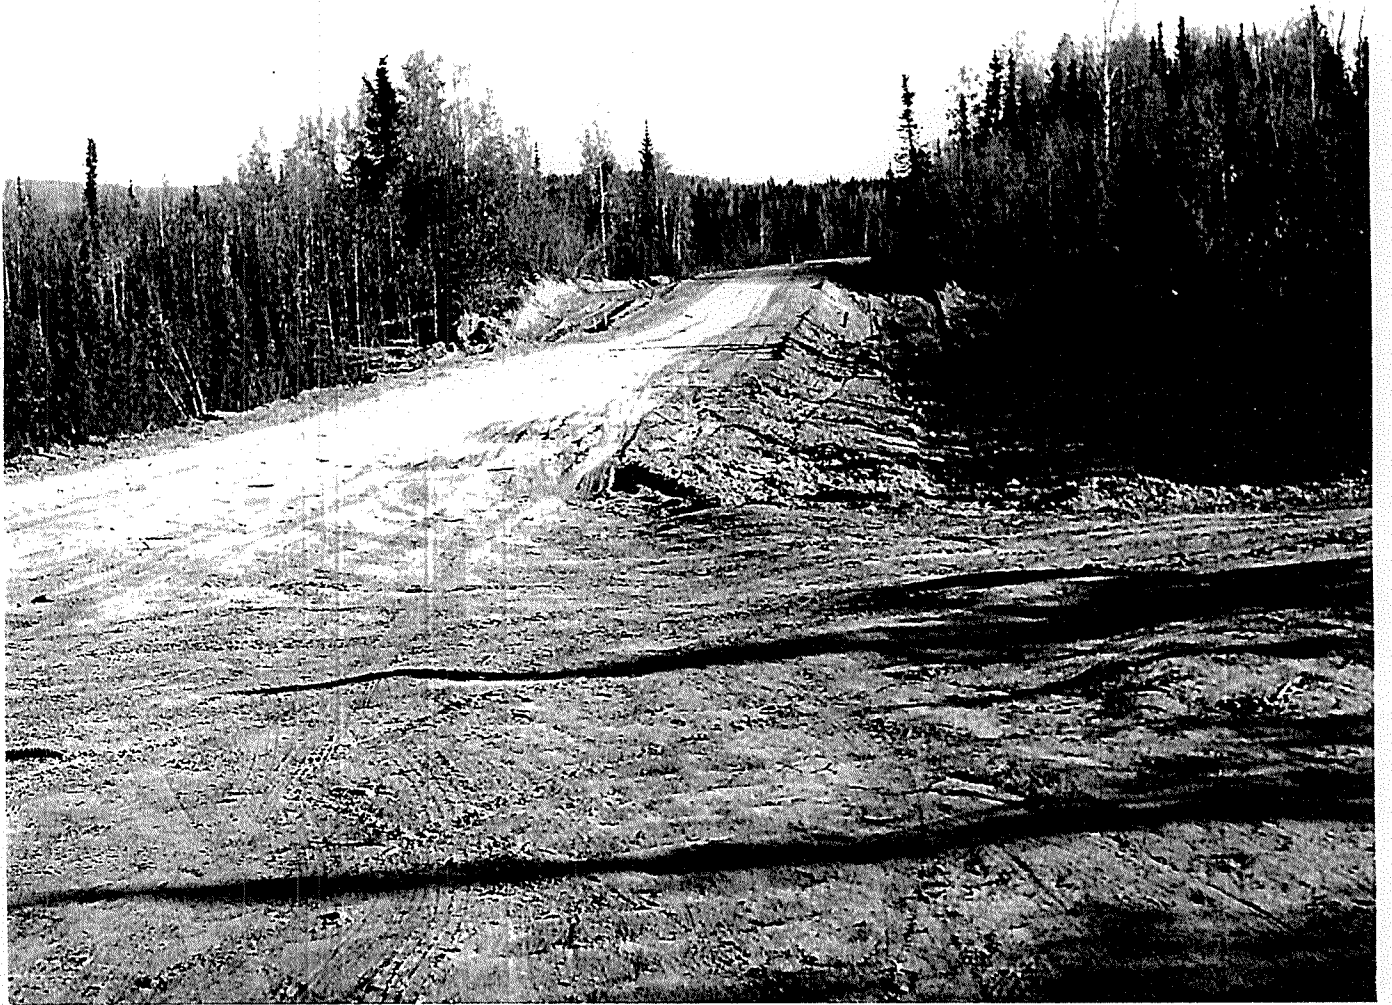
Numerous roads were driven in this area. Many of them appeared to have received minor maintenance but only one newly constructed road was found, which was Lawler Road in Sections 26 and 27, Township 1 North, Range 2 West, situated northwest of the University of Alaska Experiment Station. The new construction consisted of 1 mile of grading, draining and gravel surfacing on 1/2 mile. There was no construction activity on the road; however, a sign was posted on the east end of the road indicating that Territorial funds were being used for construction. This sign was similar to those noted on the Livengood and several other projects being built by Bureau of Public Roads forces. Therefore, it is assumed that this road was also constructed by the Bureau of Public Roads.

The cleared width is approximately 75 feet and the roadbed width is 34 feet shoulder to shoulder. The maximum fill is approximately 3 feet and the average cut and fill is estimated at 4 1/2 feet.

Fig. 9-A Parnock Loop Area - West end of
Lawlor Road.

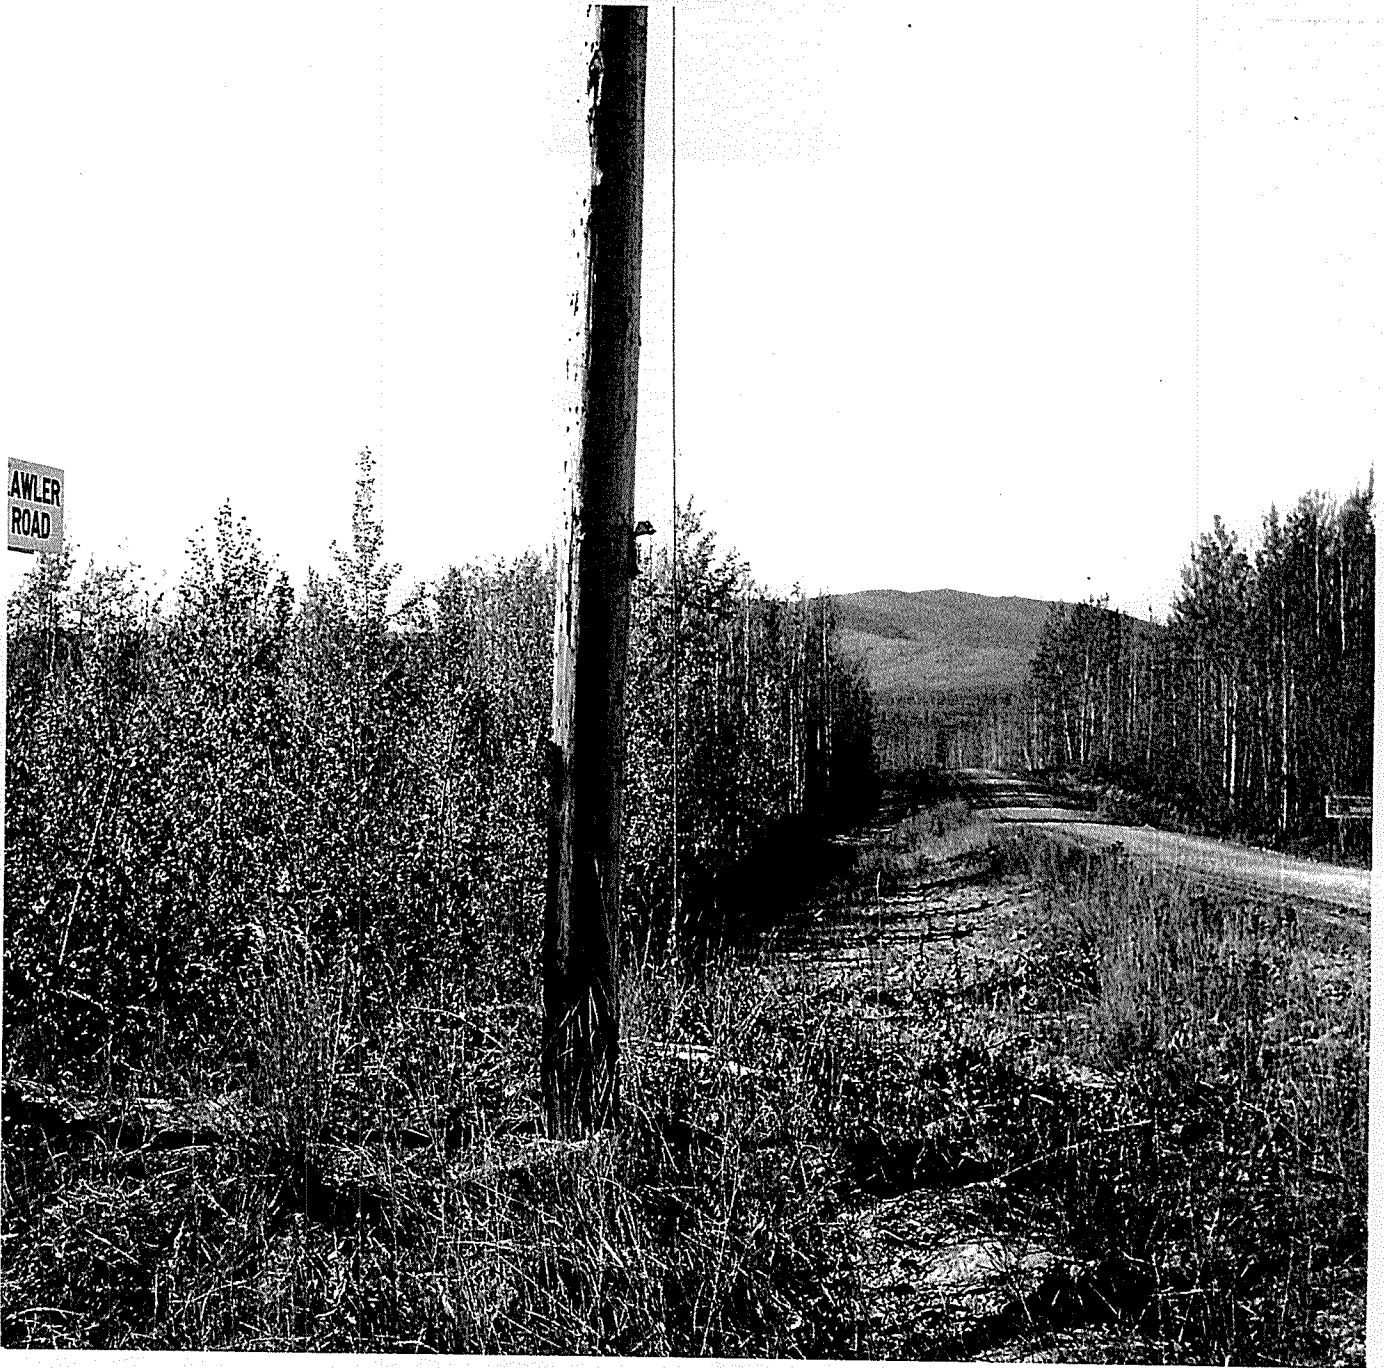
Fig. 9-B Farmers Loop Area - East end
of Lawler Road.

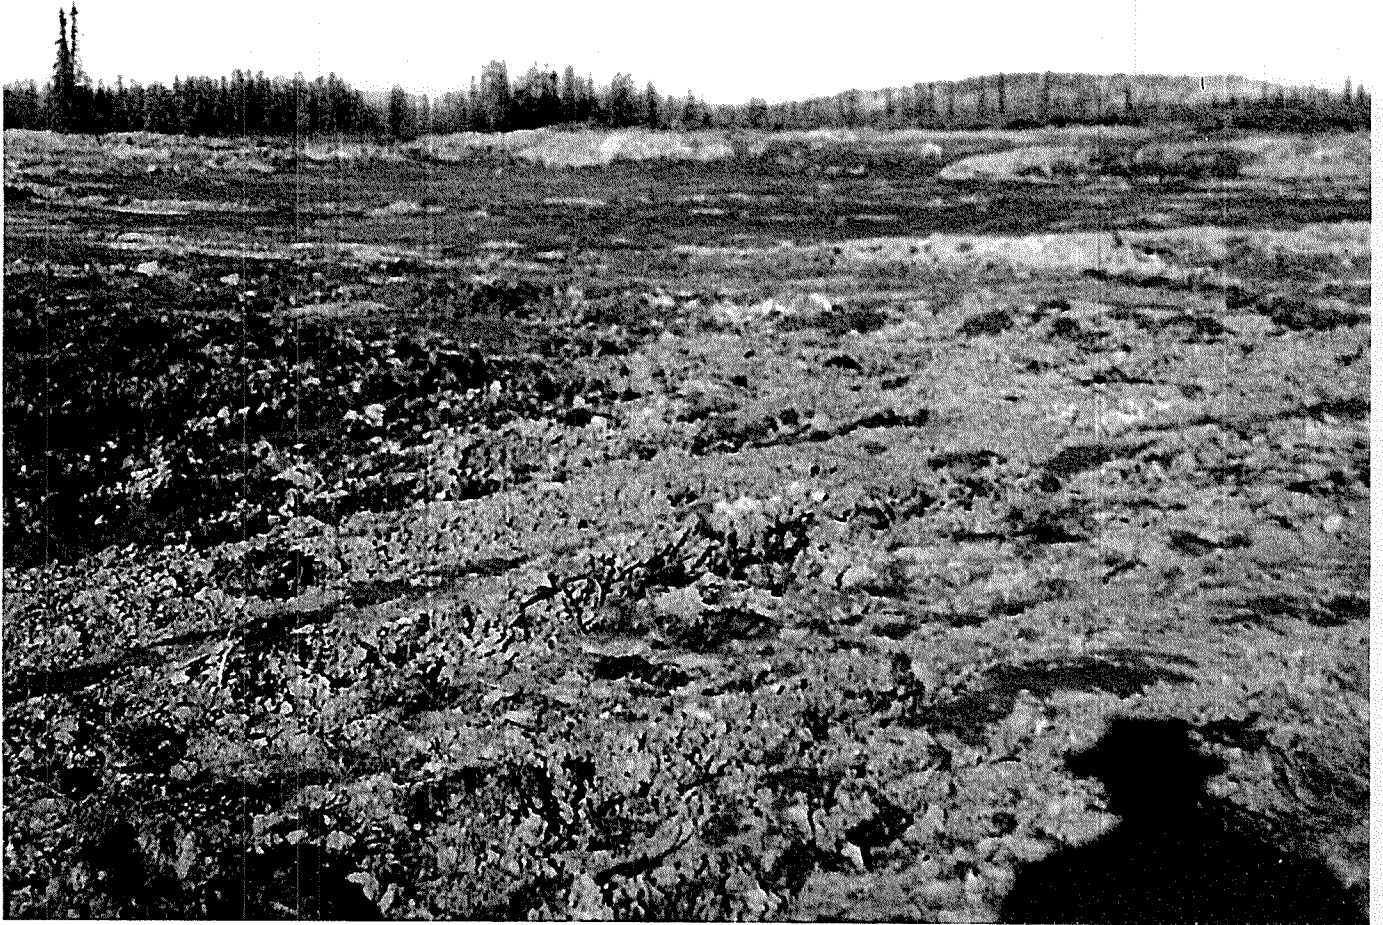
Fig. 10-A Dodge Road area - gravel pit
stripped to permit thawing.
will probably be used for
surfacing material next summer.

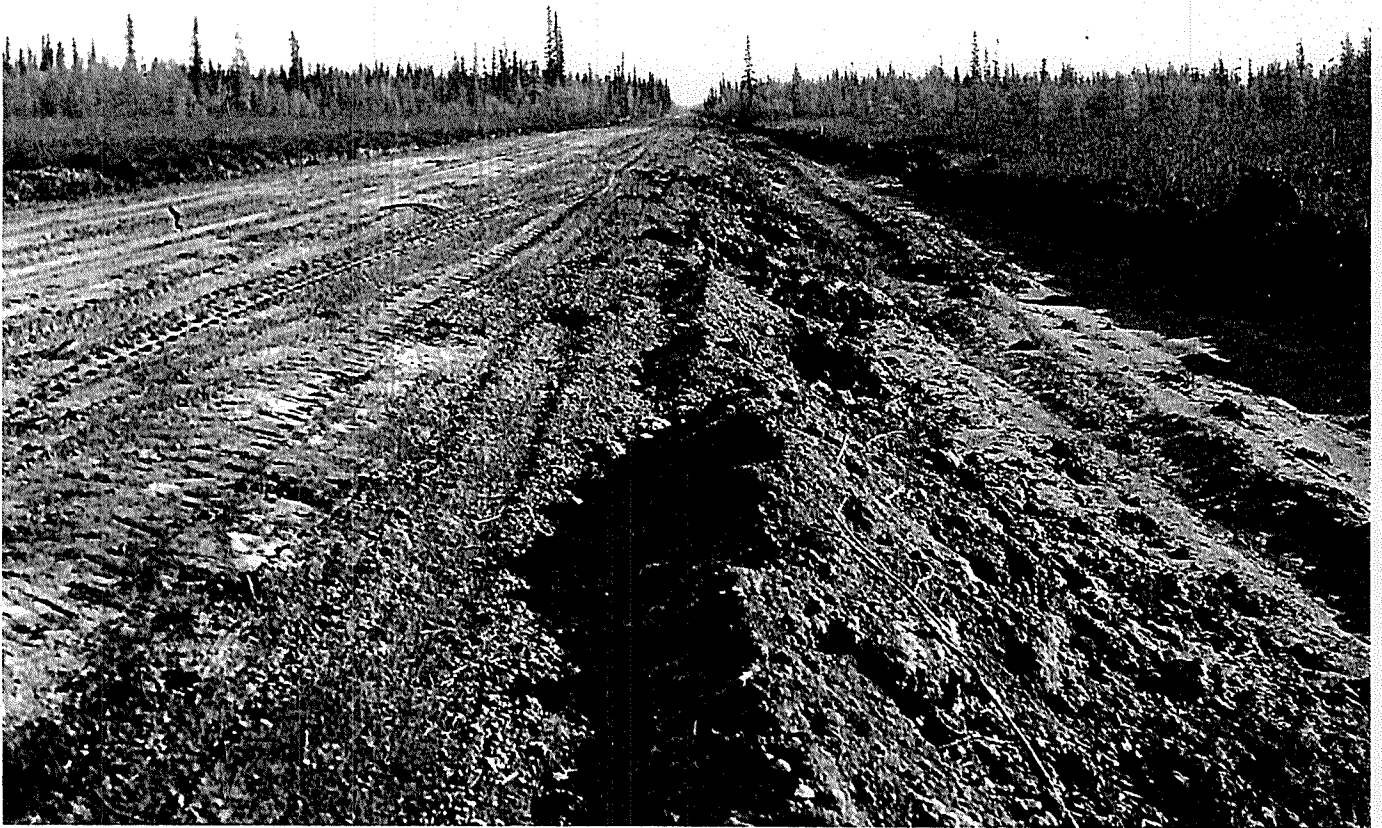
The roadbed width is 26 feet shoulder to shoulder, and a 75-foot width has been cleared and stripped.

The road traverses the flat lowlands of the Tanana River flood plains and thus, is all fill with light grades. The embankments average 4 feet in height above the bottom of the ditch line, and the material for fill was obtained from side ditch borrow. The fill is built with river silt and fine sand and will be unstable due to the high water table in this area until surfaced. A gravel pit located 3 miles from the Richardson Highway has been partially stripped and will probably be opened up next year after it has thawed.

Fig. 10-11 Budget Road Area - Typical section of Creiman Road.

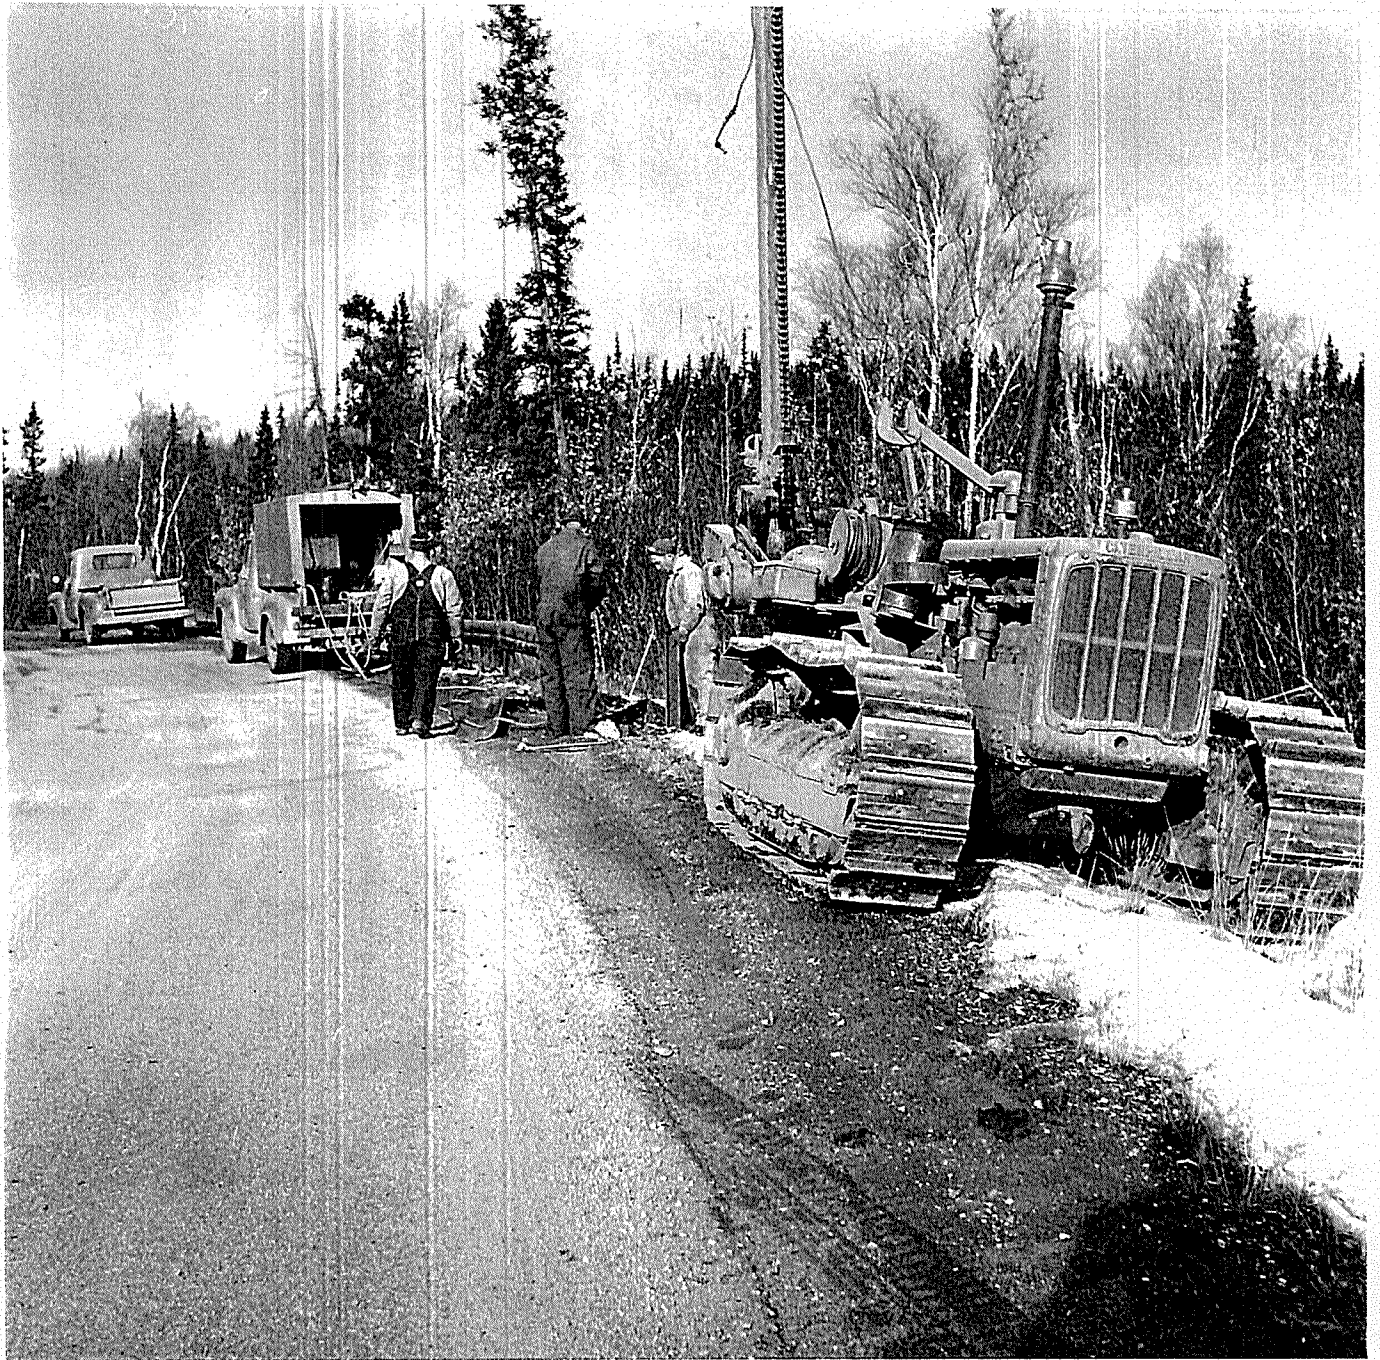
The work observed by the writer consisted of the installation of a guard rail approximately 1 mile north of the Richardson Highway bridge crossing the Tanana River near Big Delta and the installation of a culvert under the Alaska Highway approximately 1/2 mile south of the Alaska-Richardson Highway Junction near Big Delta.

Fig. 11-4 Big Delta area - Installation of guard rail on Richardson Highway near Big Delta.

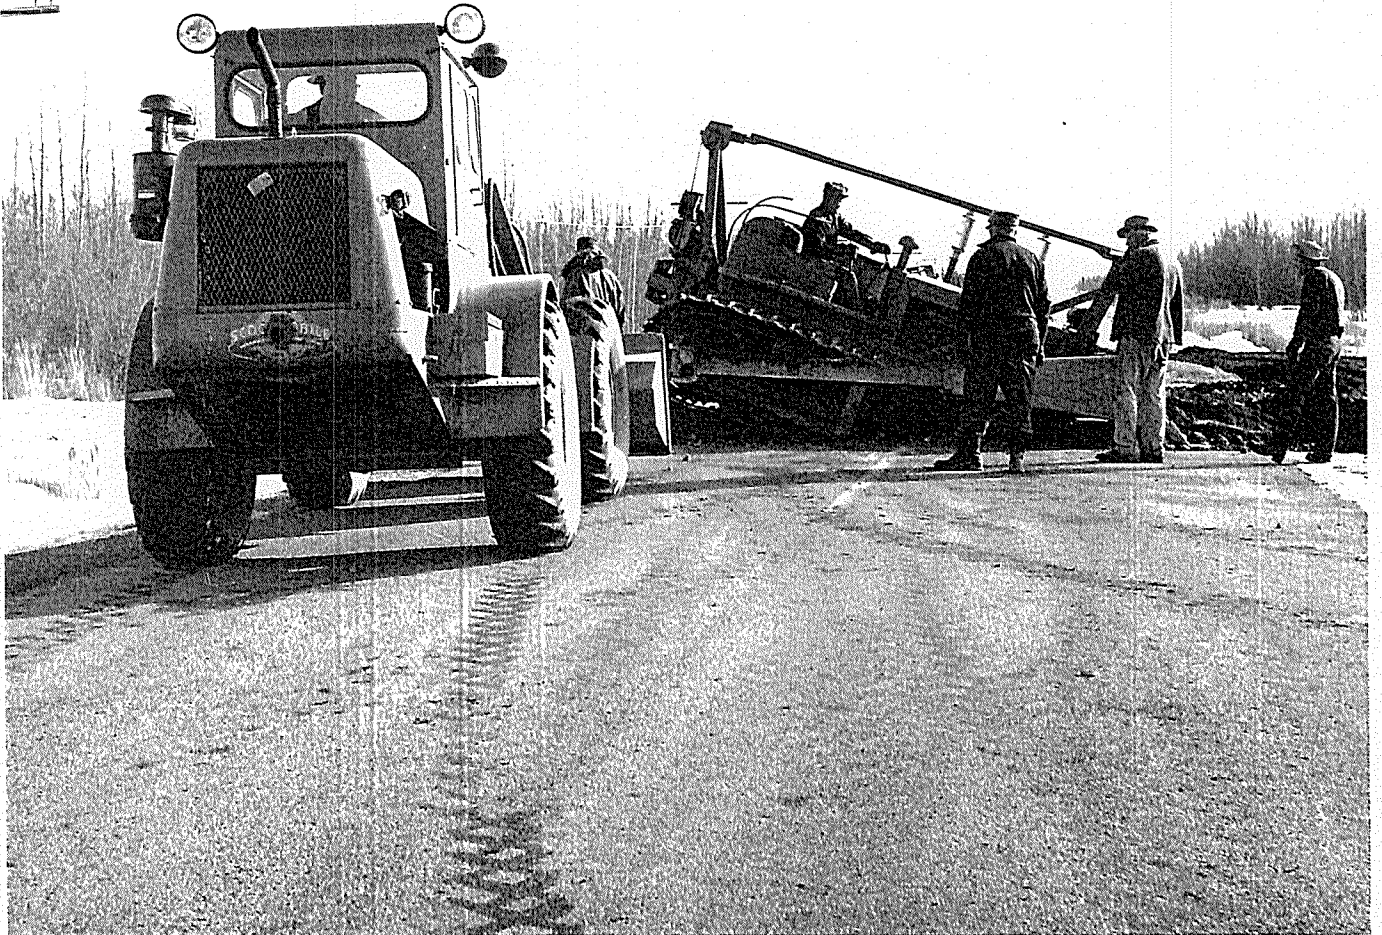
Fig. 11-B Big Delta area; installation of
CMT culvert on Richardson
highway near Big Delta.

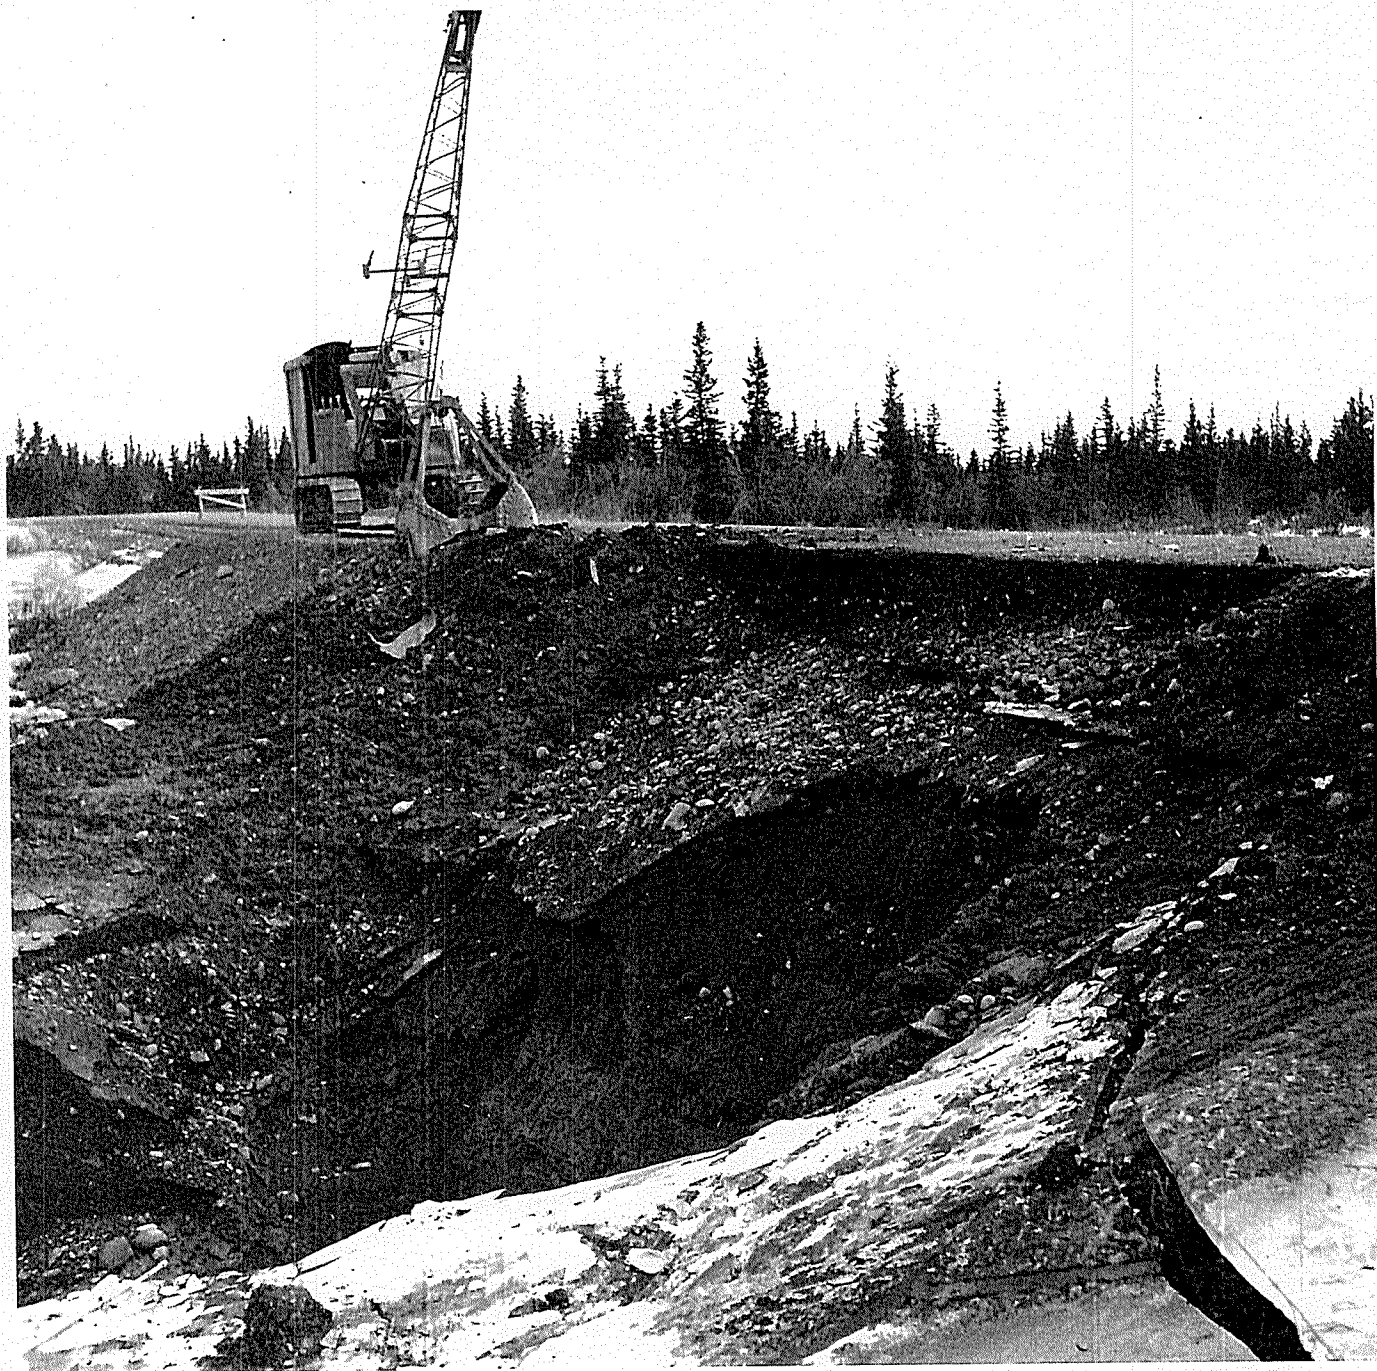
Fig. 13-A

The work consisted essentially of a leveling course and asphalt surfacing in areas that had settled or failed in shear. The patches varied in thickness and width and were approximately 50 feet to 200 feet in length. A typical shear failure is shown on the attached photograph and usually results in a slough in and longitudinal crack in the surfacing caused by too steep a fill slope, too narrow a shoulder to provide adequate lateral support or a combination of both. This type of failure is quite prevalent on Alaska's primary system.

The Junction - Gulkana.
Slough in on Glenn Highway.
Head walls on culvert intake
would probably correct this
type failure.
