Construction of the Alcan Highway in 1942

**“One of the Top 10 Construction
Achievements of the 20th Century”**

J. David Rogers, Ph.D., P.E., P.G.

**Karl F. Hasselmann Chair in Geological Engineering
Missouri University of Science & Technology**

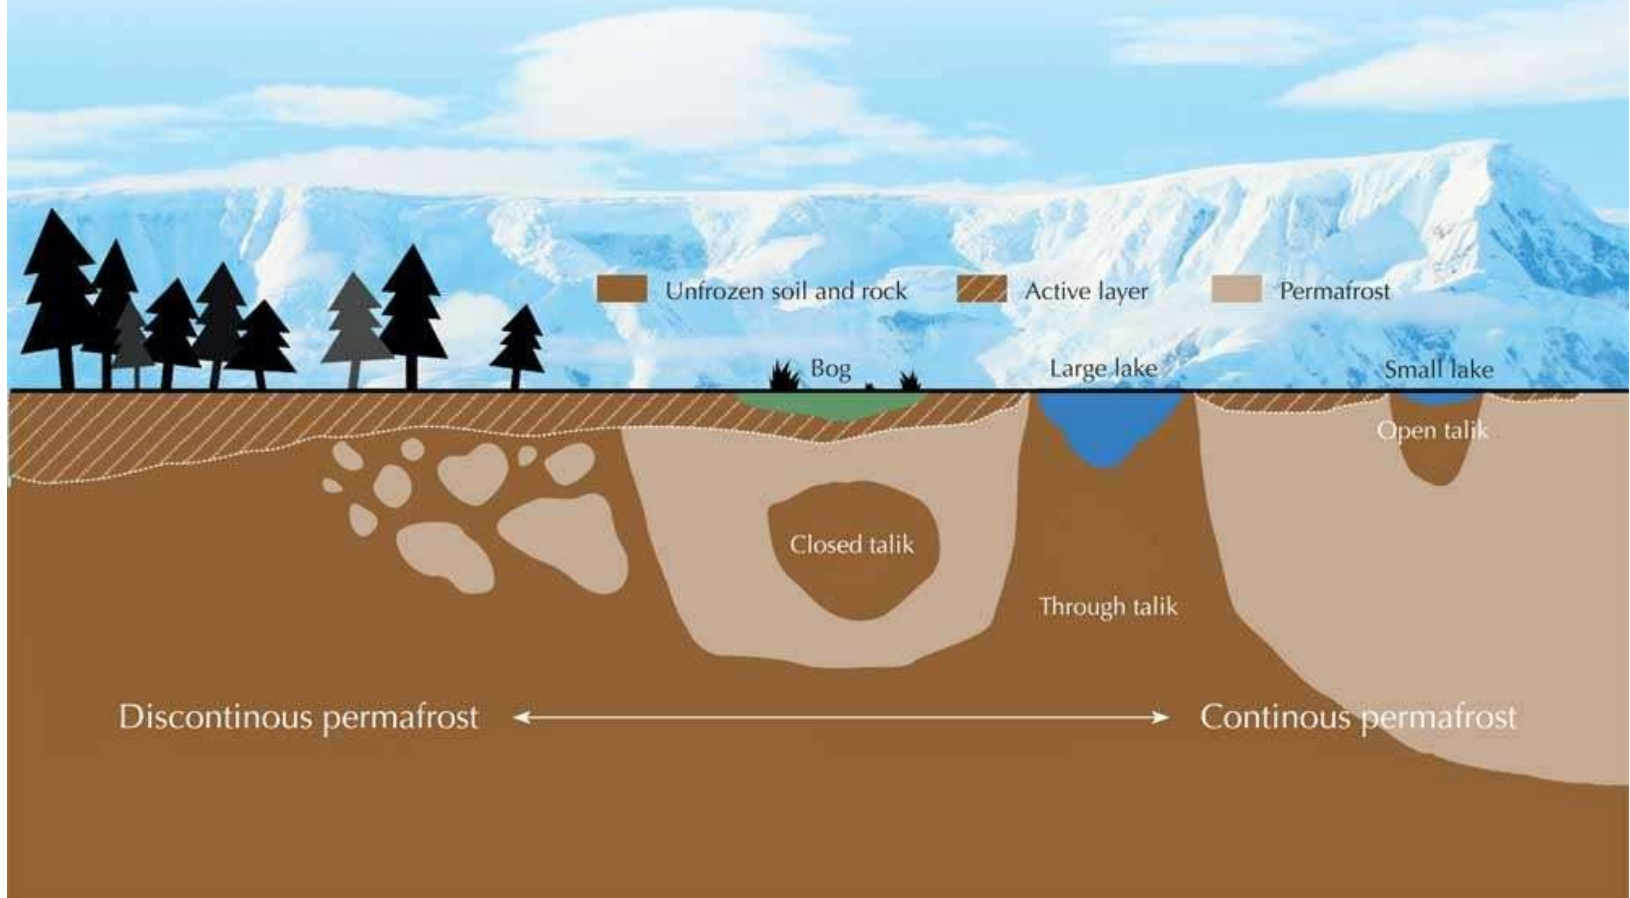
Types of Permafrost

Permafrost is the *permanently frozen subsoil* beneath cover of vegetation and top soil (the active layer). The active layer topsoil insulates the frozen subsoil.

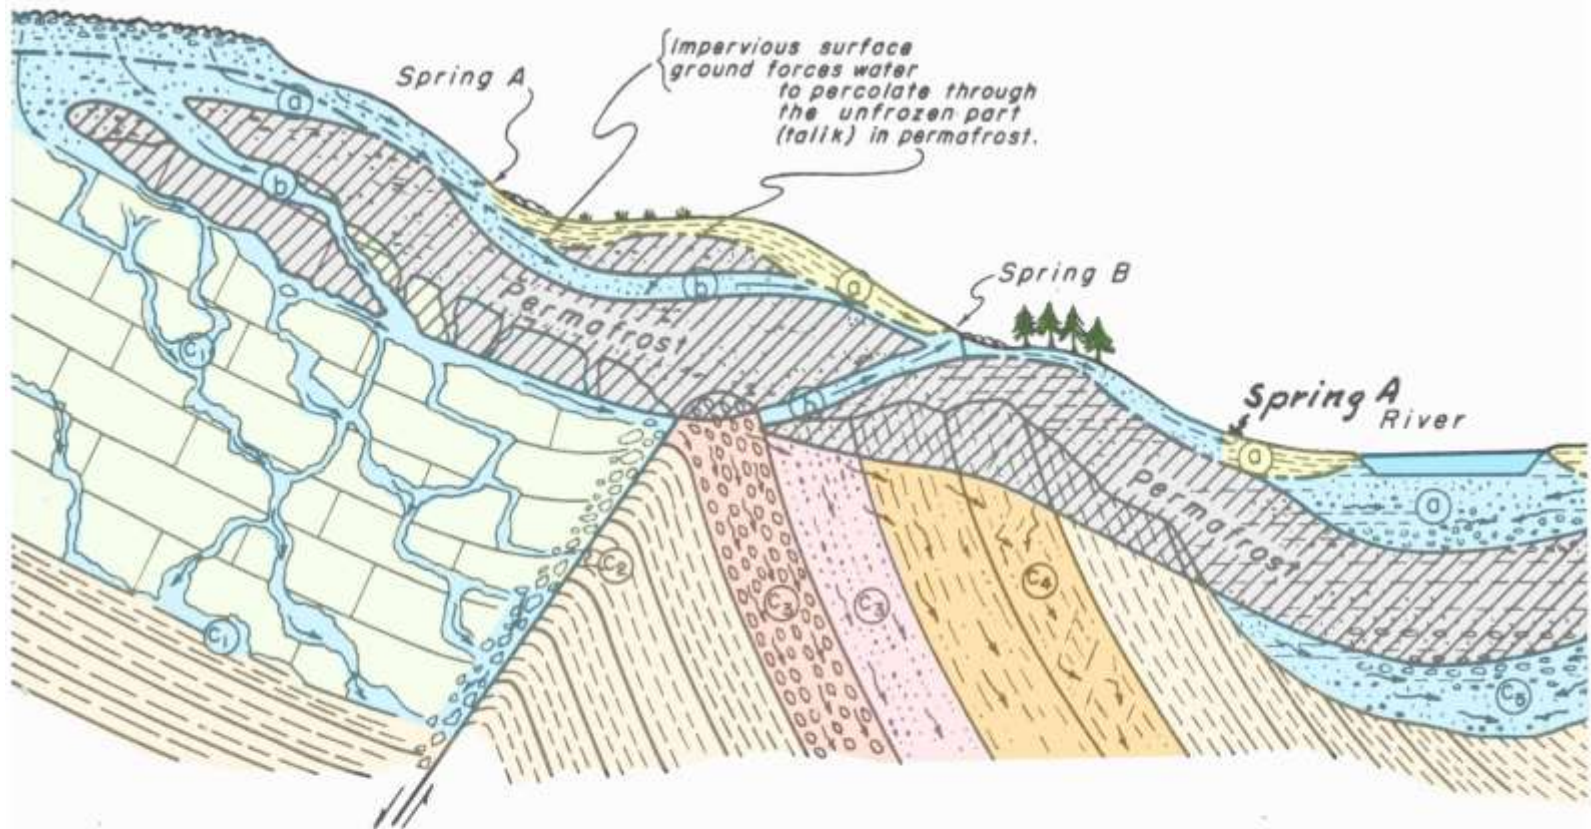
DIAGRAM SHOWING DIFFERENT OCCURRENCES OF GROUND-WATER

IN THE PERMAFROST REGION Taken from Muller (1947)

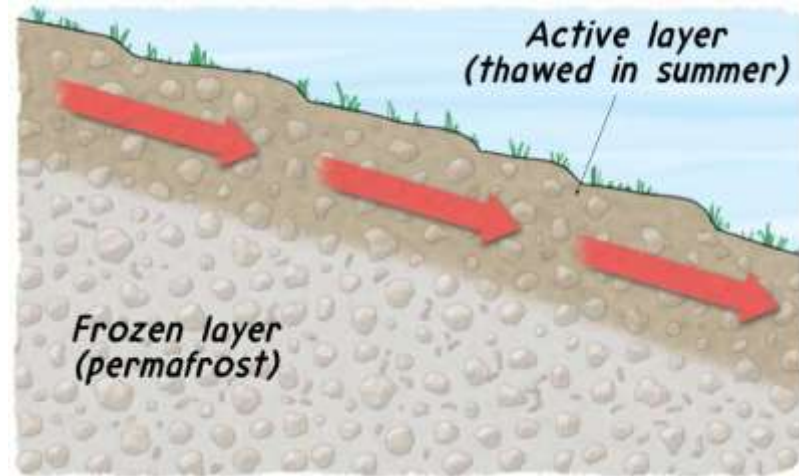
SOLIFLUCTION

- Soils in the thawed active layer overlying the permafrost tend to creep downslope during the warm season through a process known as **“solifluction.”** This process is exacerbated by the inability of percolating rainfall to penetrate the permafrost, leading to the active layer becoming super saturated.

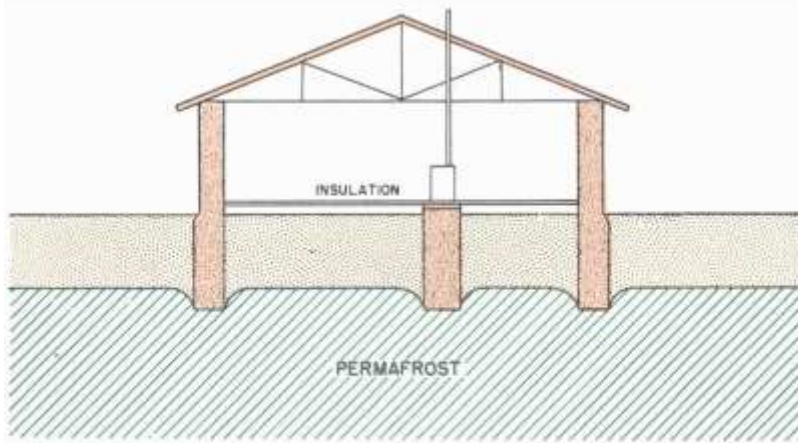
Maximum permissible lowering of the permafrost table beneath a foundation.

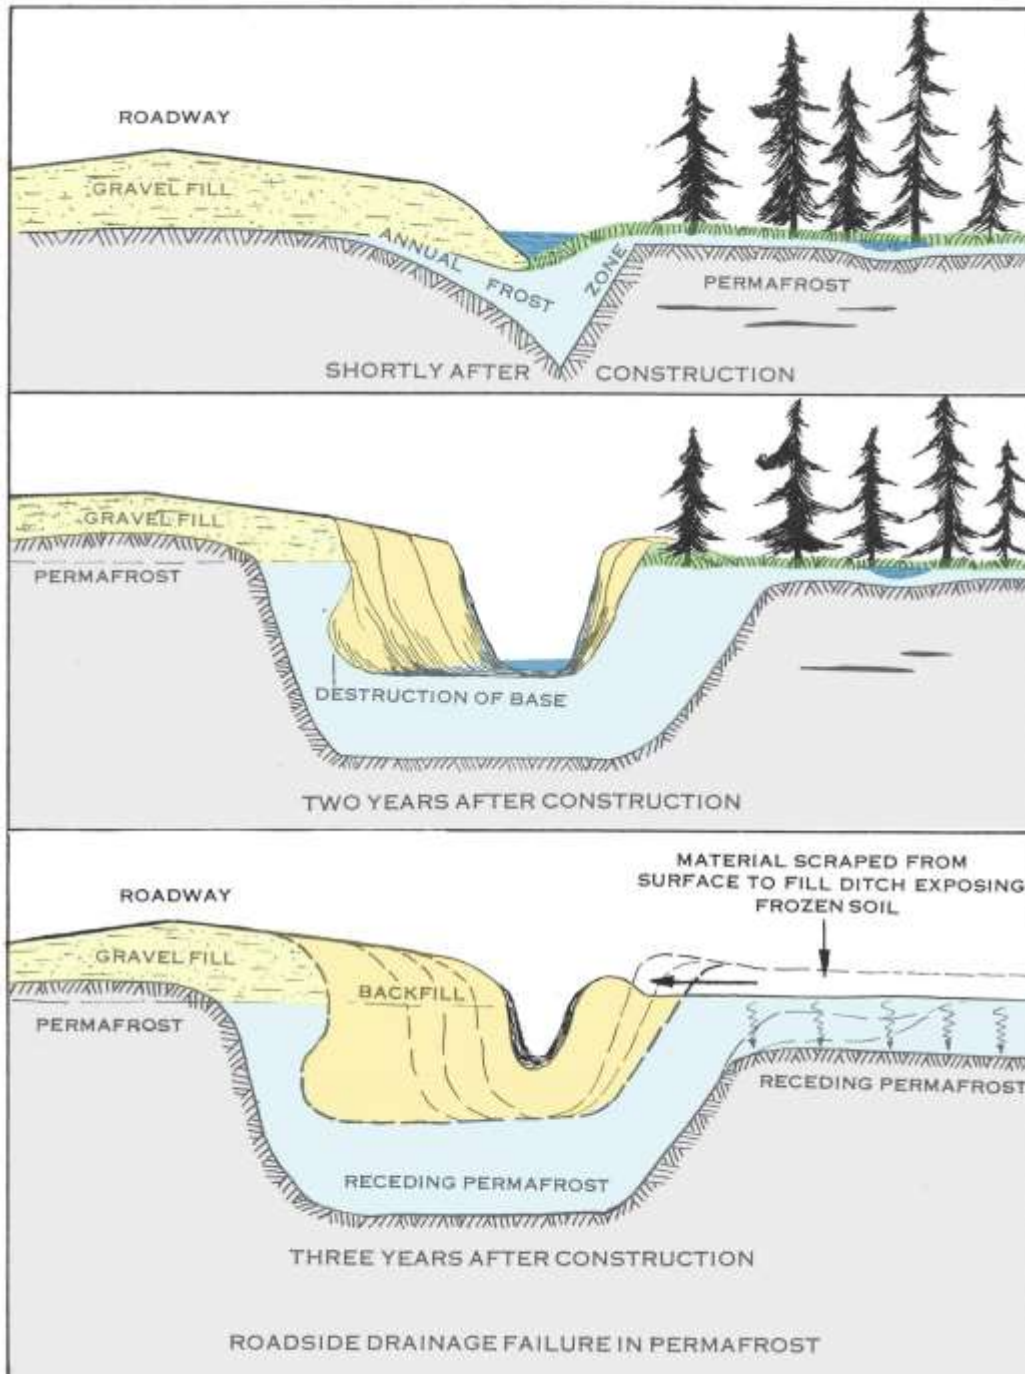
Roadside drainage failure in permafrost

- The road's subgrade was almost completely undermined by thawing of permafrost, which resulted in the sloughing of the saturated soil.
- This problem was caused by the excavation of the roadside ditch, which was unnecessary
- The problem was exacerbated by drifting in fill from adjacent to the highway to fill in the collapsing ditch, as shown in the lower figure at left

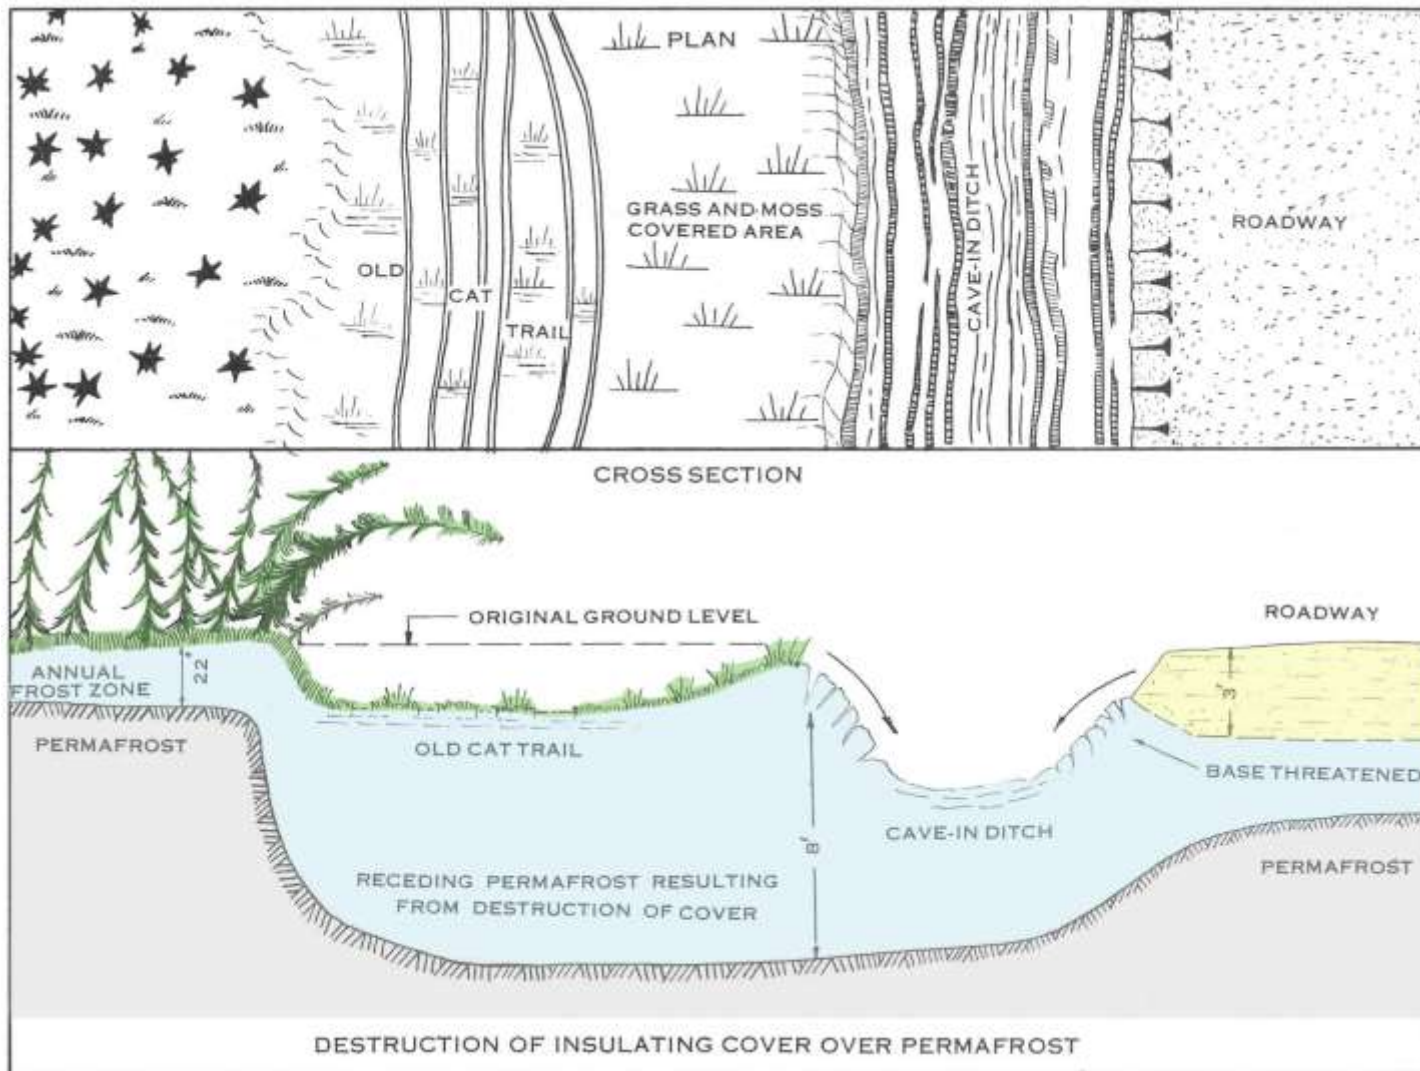
- Old Caterpillar tractor trails excavated on permafrost allowed water to pond and infiltrate zones adjacent to the Alcan Highway, causing it the highway subgrade to be undermined.

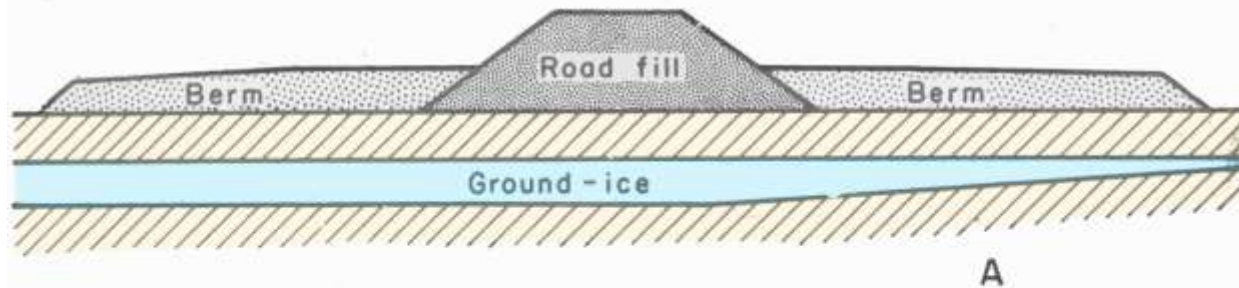
Melting of ground-ice and slumping of road fill is checked by the construction of berms.

- In reviewing the Russian technical literature, Muller soon discovered that they employed shoulder berms to check shoulder slumping and deterioration.

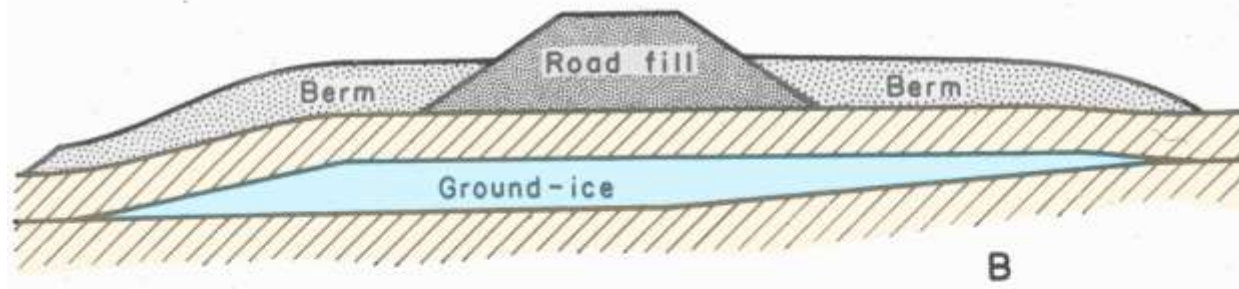
(After Bykov and Kapterev)

Effect of berms in preserving the frozen condition beneath a road fill.

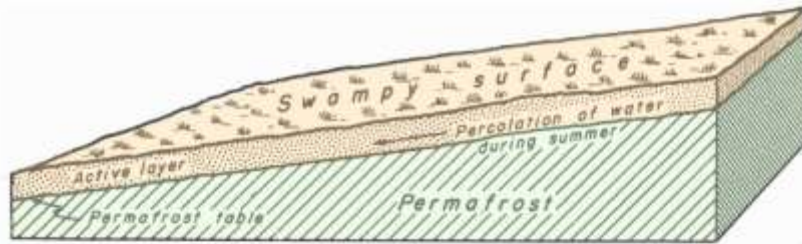
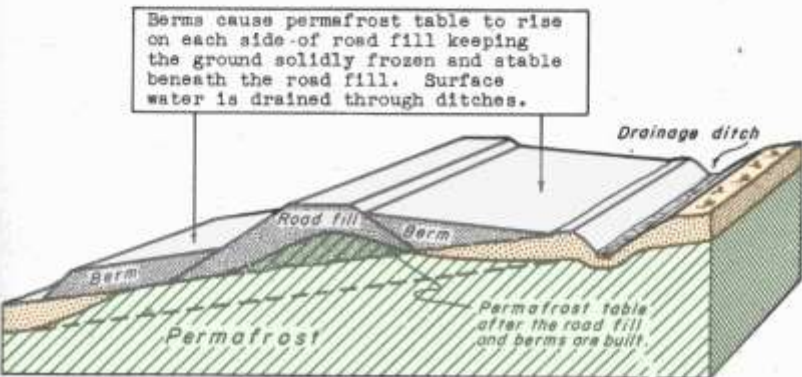
- When constructing a road, it is common procedure to remove the topsoil. But, when the active layer was excavated, the underlying permafrost thaws out and deforms easily because of the high water content.
- Stabilizing fill berms on either side of the highway fill prism help to alleviate this problem, as shown here

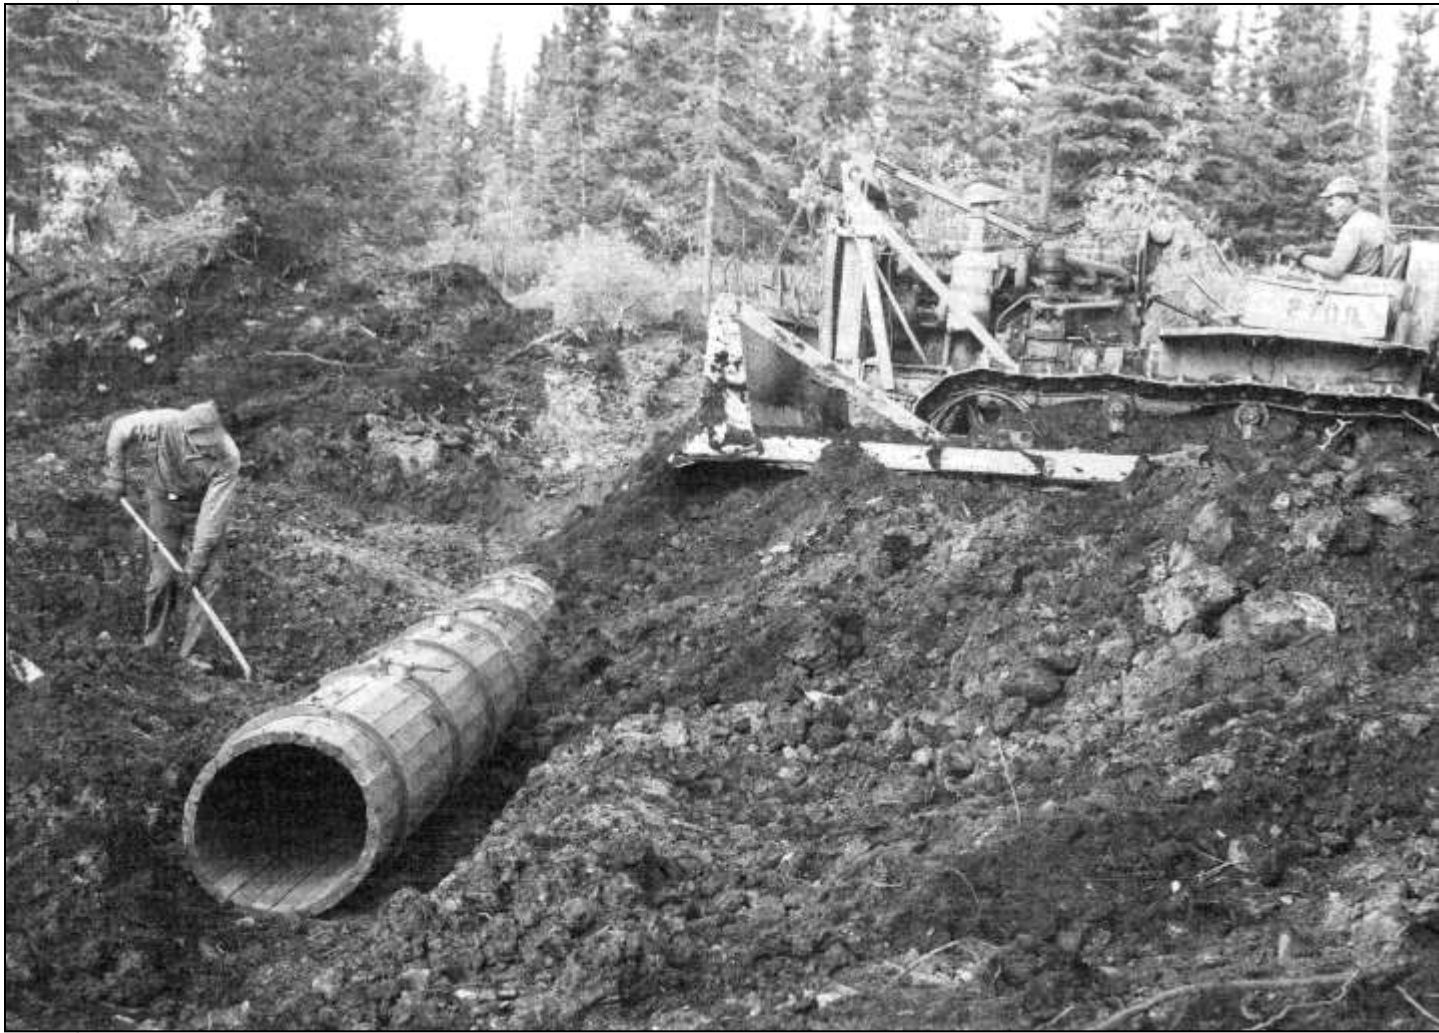
- **“Compaction dams”** could also trigger wholesale landslippage along even the smallest culverts, as sketched here.

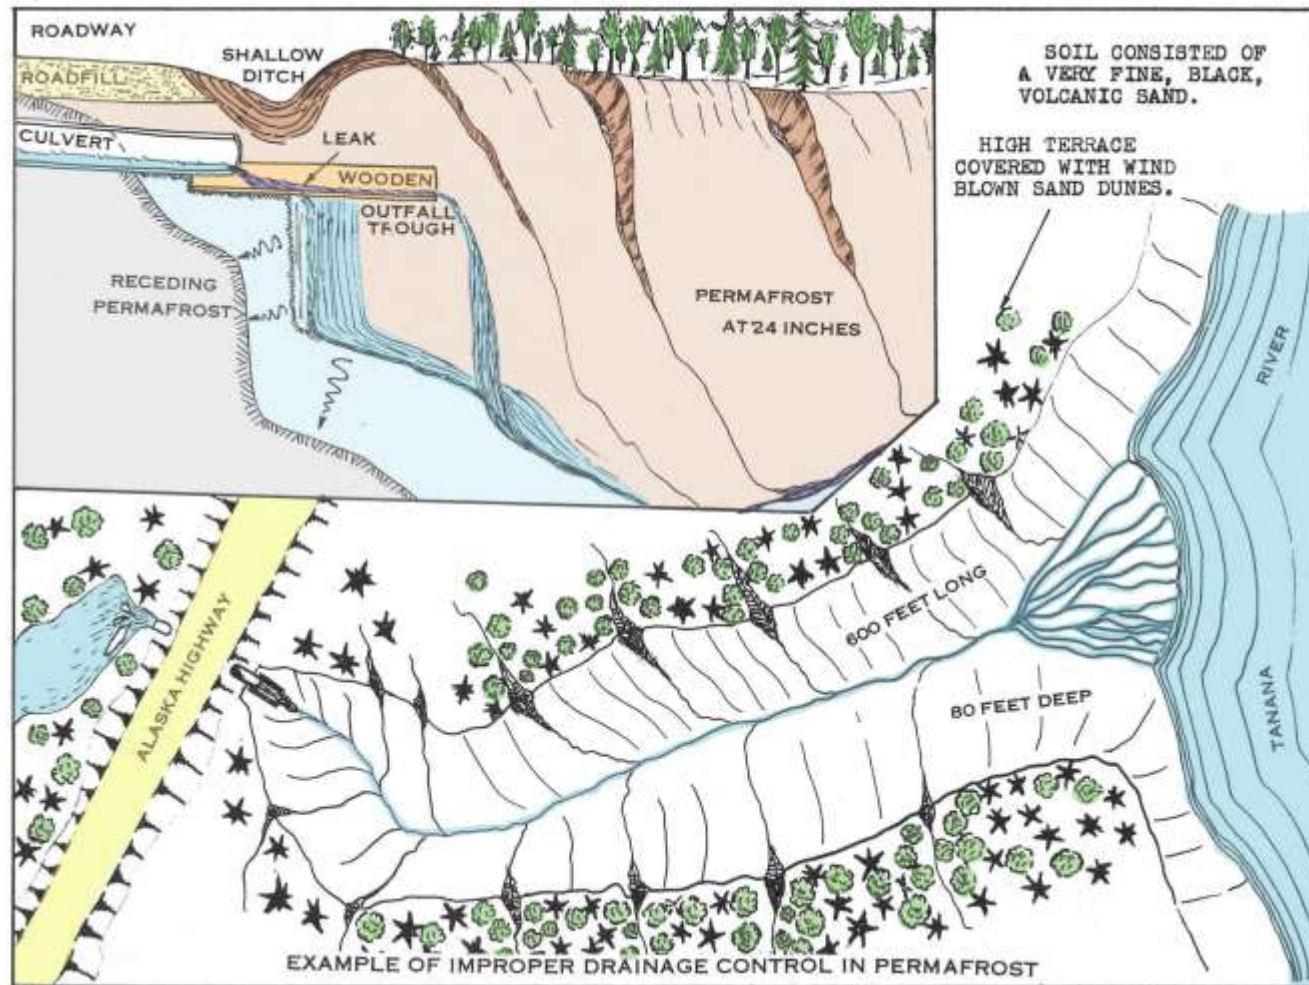
- This drainage ditch was cut by a dozer to channel discharge from a culvert to the Tanana River in 1942. Within a year this seemingly innocent ditch had excavated itself over 80 vertical feet, as a result of exposing permafrost to thaw.

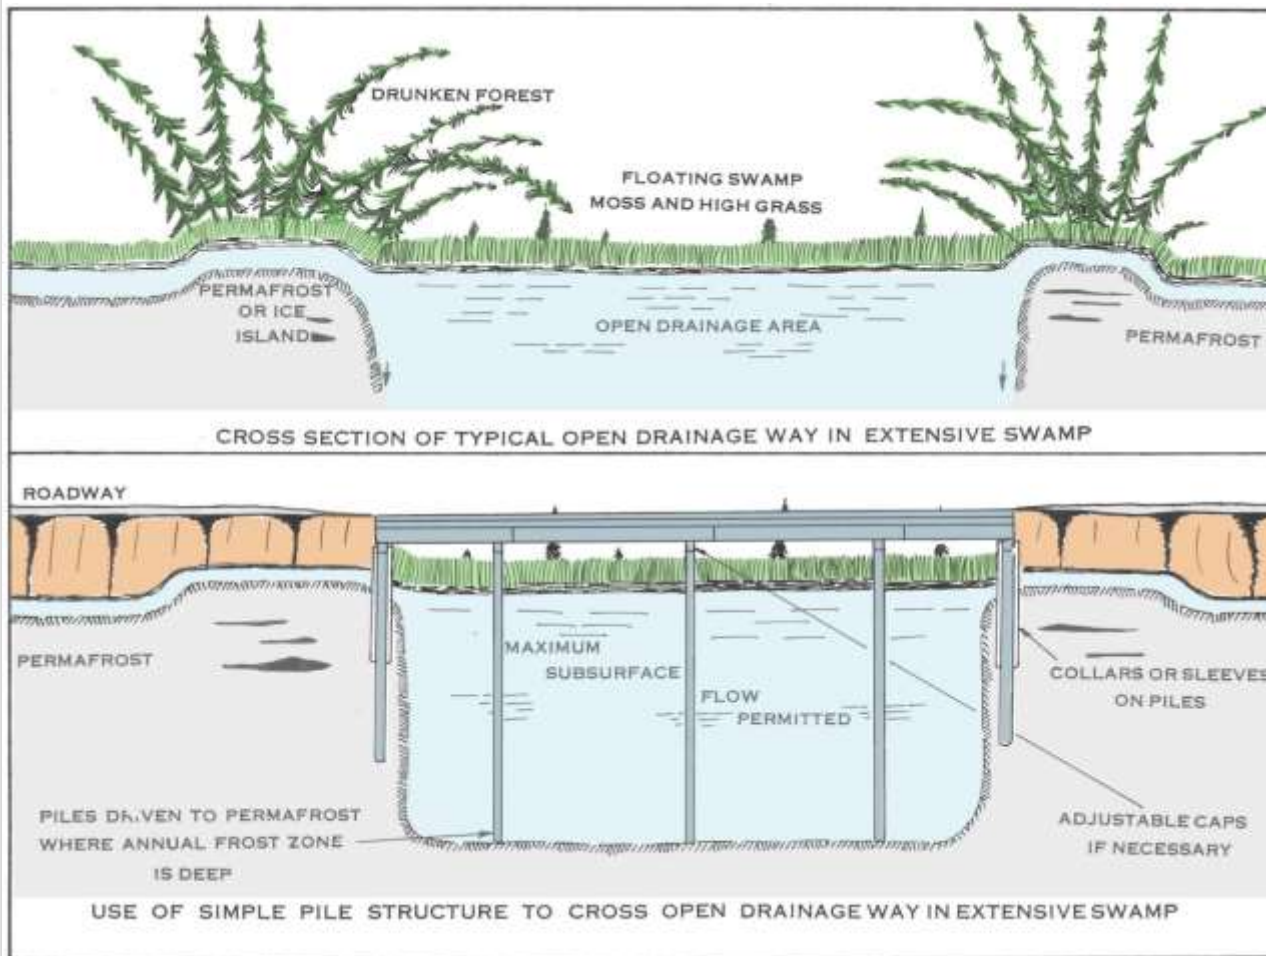
- This shows an **open drainage way** crossing the highway. These features convey large volumes of seasonal subsurface seepage flow. These situations were eventually met by using low pile supported bridges with adjustable caps on either end to allow for **settlement and heave**.

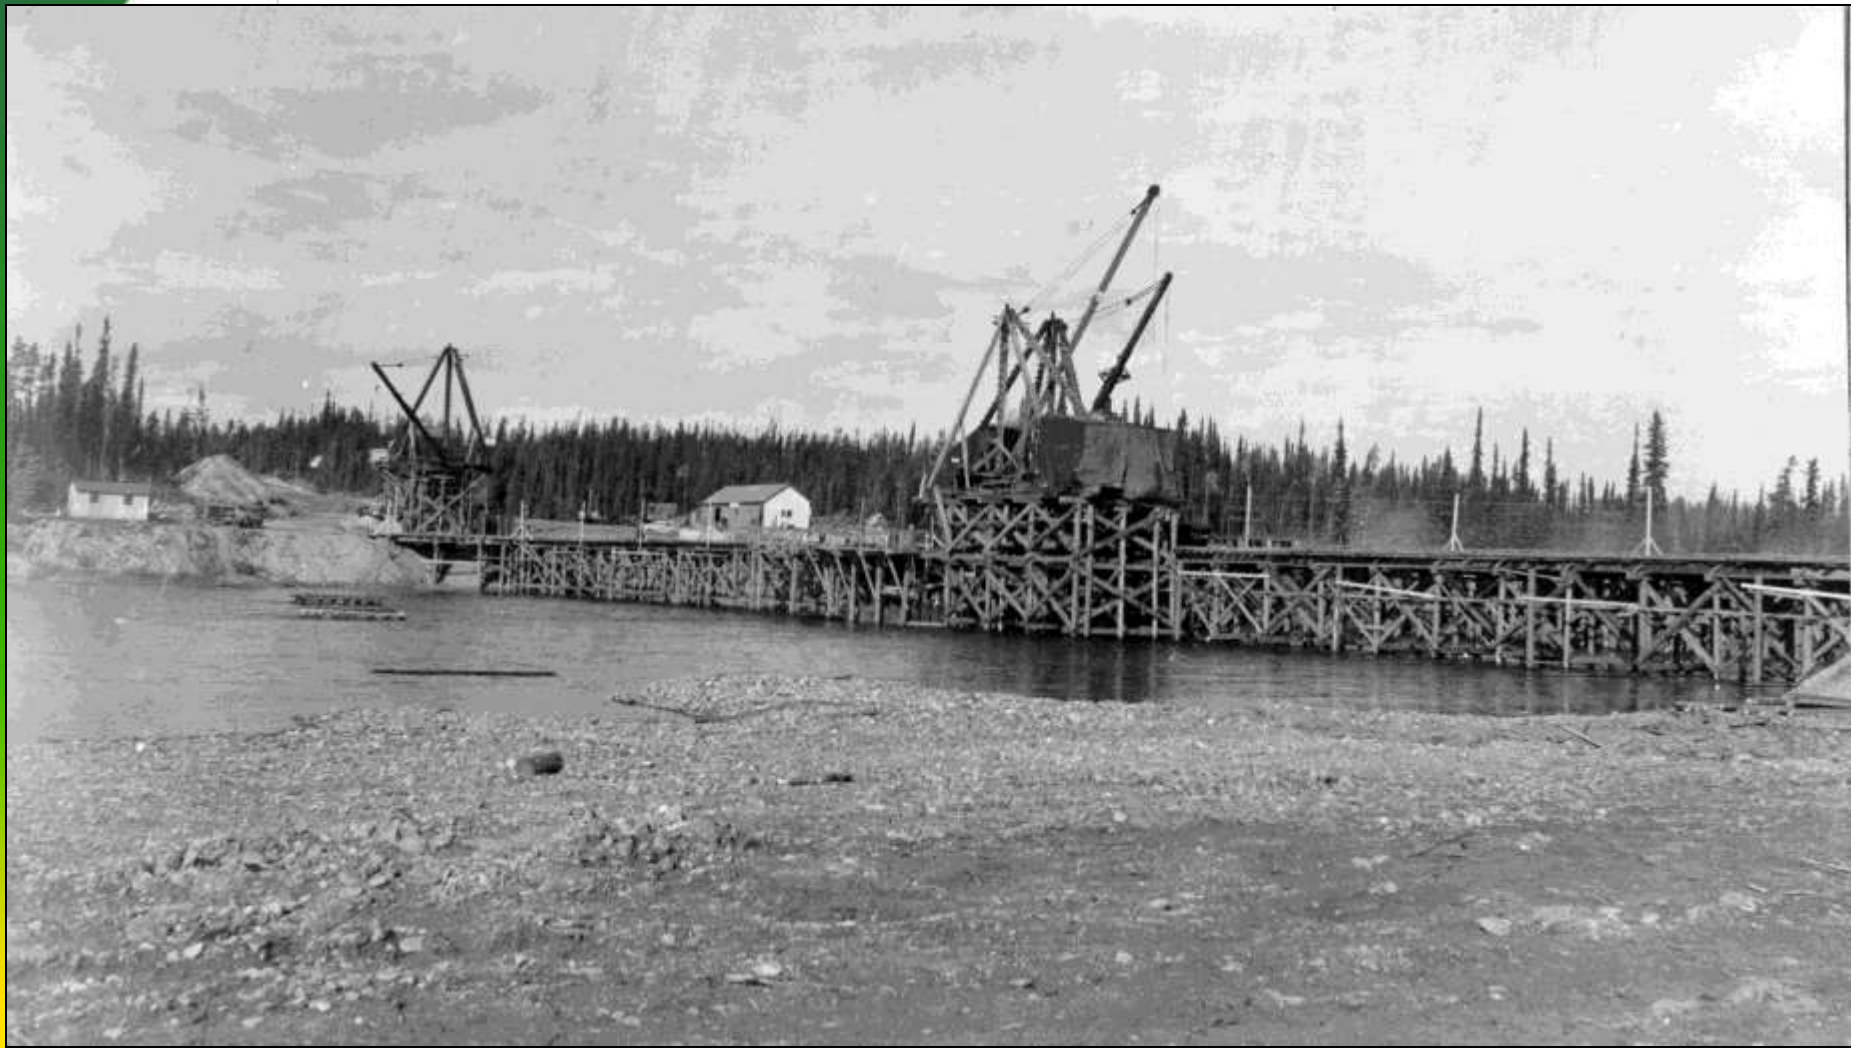
- **Timber trestle bridges like this were unable to handle summer freshets, which brought innumerable driftwood and fallen trees into the pilings.**

- **Maintaining the bridges posed the biggest problem. During construction, a guard was posted to make sure that large trees brought downstream did get snagged by the bridge pilings, which could easily damage or destroy the bridge.**

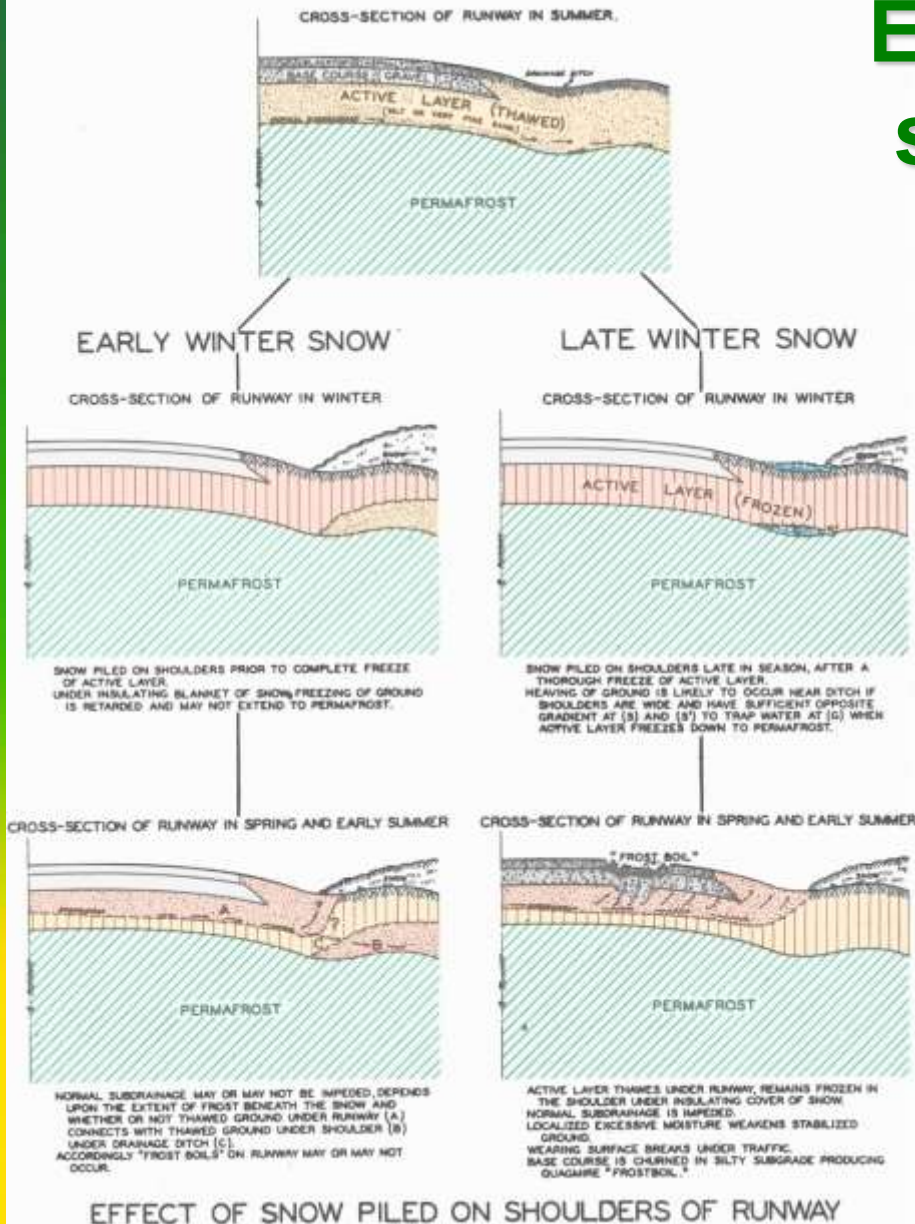
Effect of snow piled on shoulders of runways

Snow piled along shoulders of Alaskan runways often prevented the active layer from thawing, leading to deterioration of the shoulders, as shown at lower right.

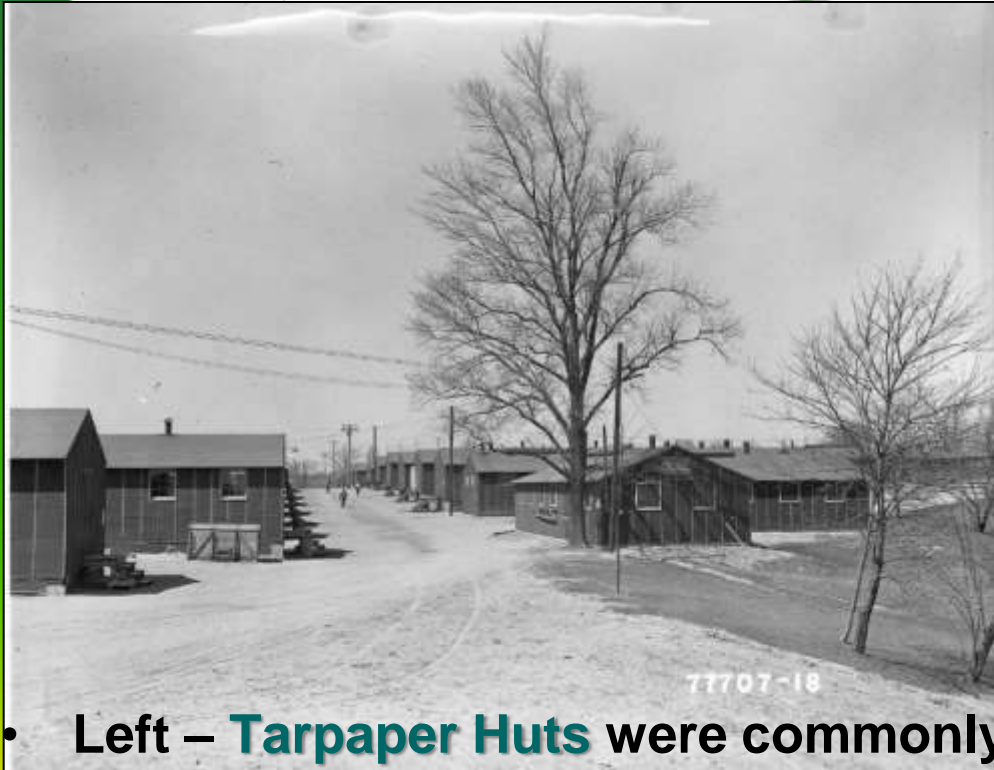
- Left – **Tarpaper Huts** were commonly employed for billeting troops at training facilities all over the world
- Right - **Jamesway Huts** were fashioned from multiples of 4' x 16' hemispheres, produced by the James Manufacturing Co of Fort Atkinson, Wisconsin. These used wooded ribs and insulated fabric covering, the only metal parts being nails, fasteners, and connecting bars.

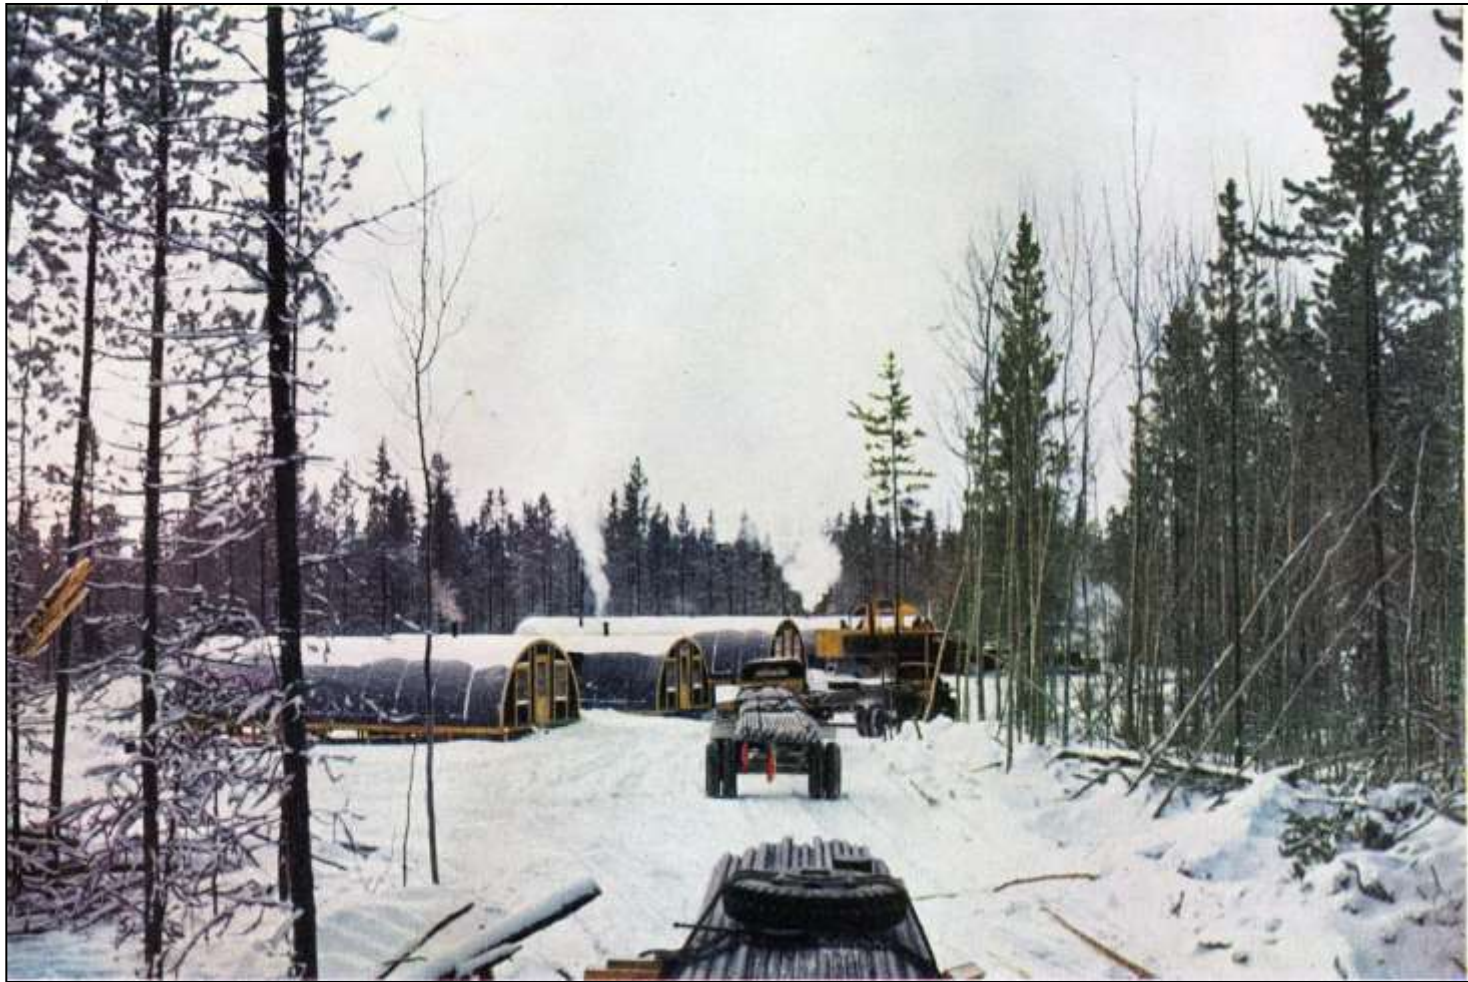
- **Portaseal Huts** utilized a tar-paper exterior nailed to plywood sidewalls, end walls with large windows, and wide batten-type trim boards over the joints.

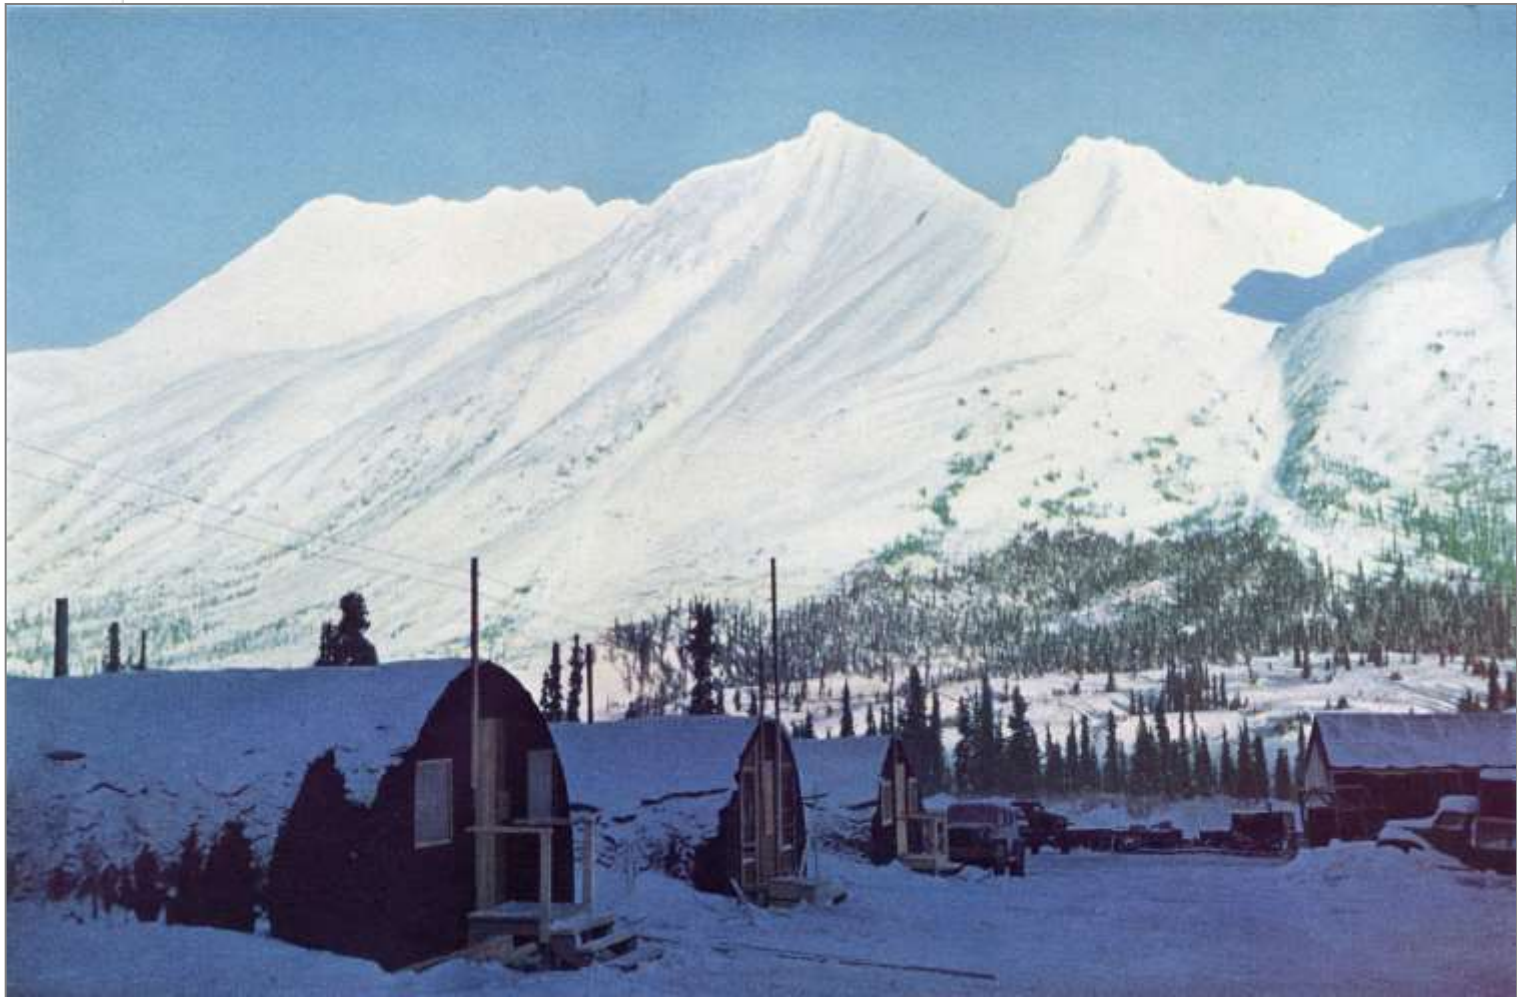
- **Portaseal Huts** were used on the Canol Pipeline Project and on the Alaska Highway, where it crossed the Yukon Territory. They were heated with improvised oil drum stoves.

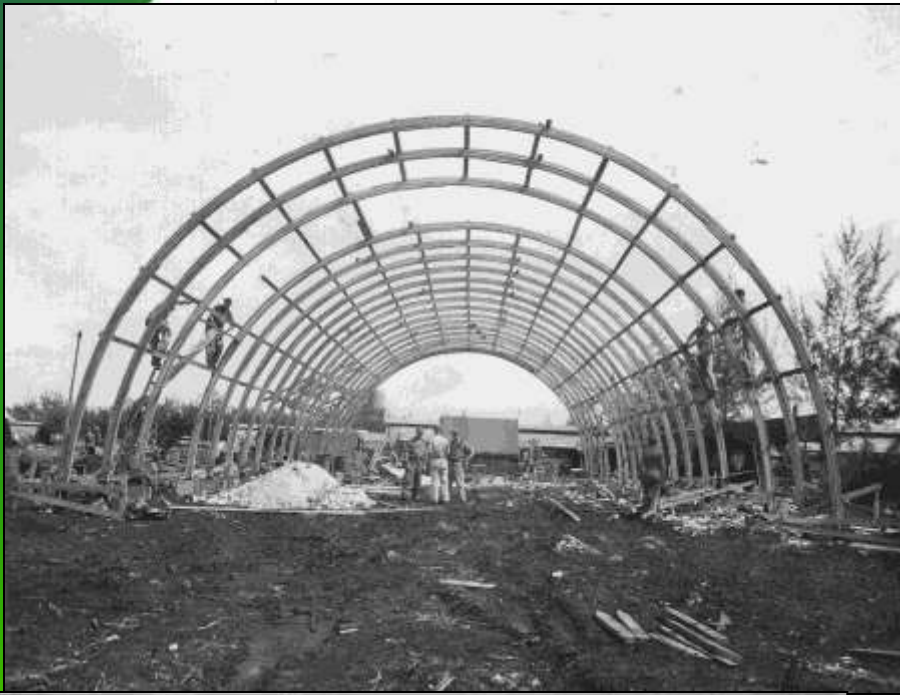
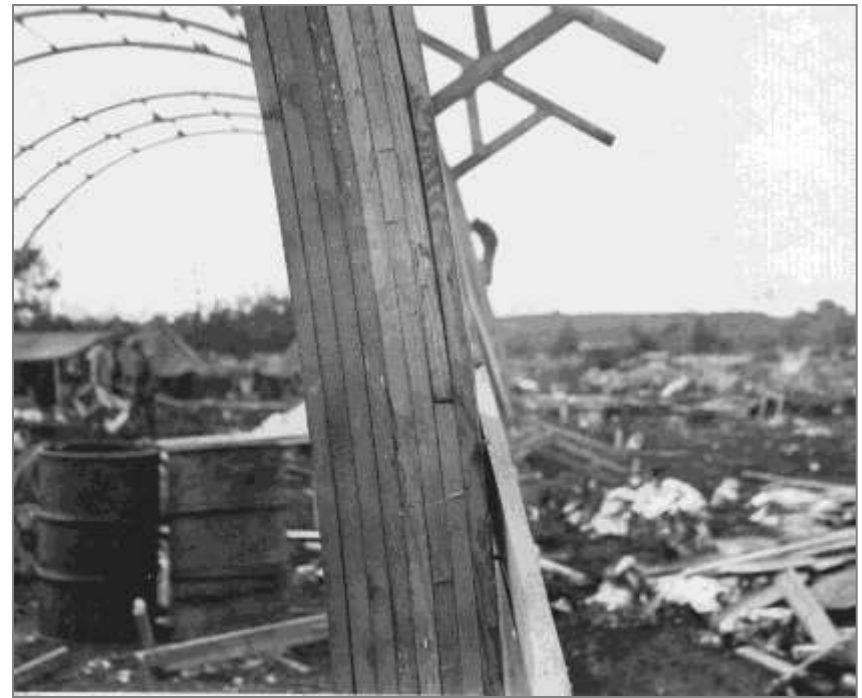
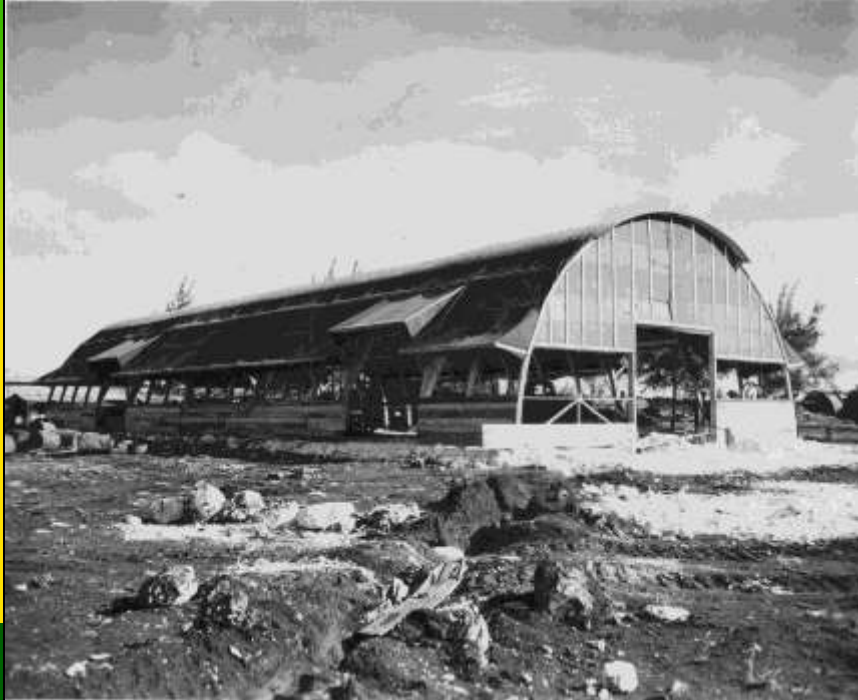
- **Glue-laminated wood ribbed huts** began appearing towards the end of the war, as a means of conserving steel. These kits allowed considerable alteration to accommodate the prevailing weather conditions.
