Godspeed Gold Dredge No. 8 versus Fairbanks Gold

MARTIN GUTOSKI, PS02.08.2021

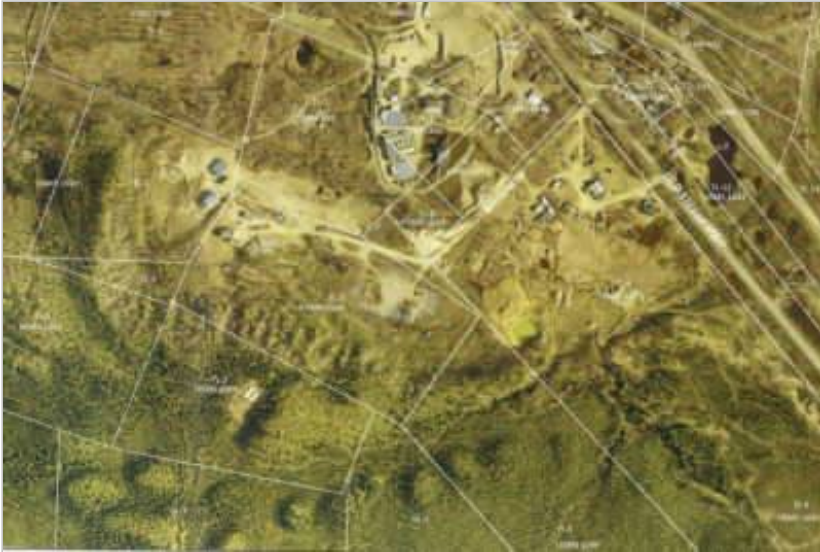
FNSB GIS exhibit showing Gold Dredge #8 in pond between TL-2 & 9 on portions of USMS 851 & 1643.

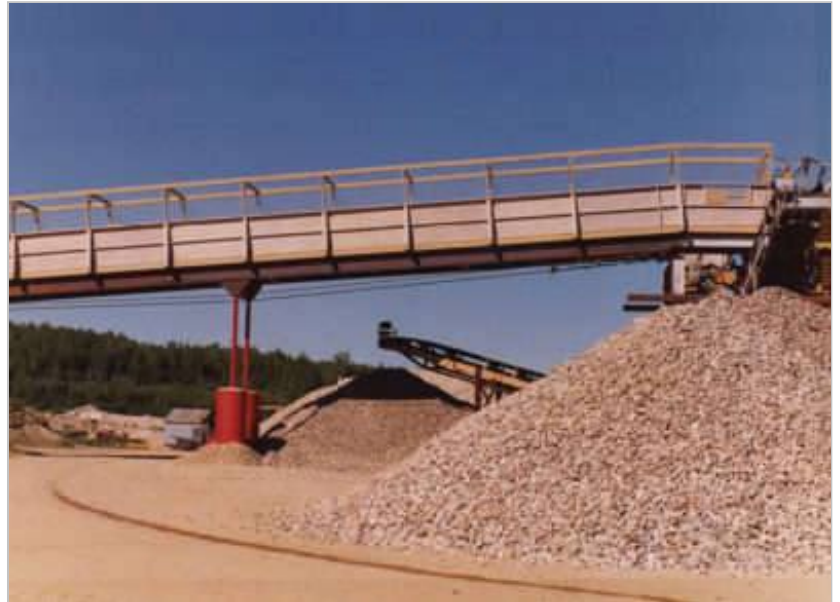
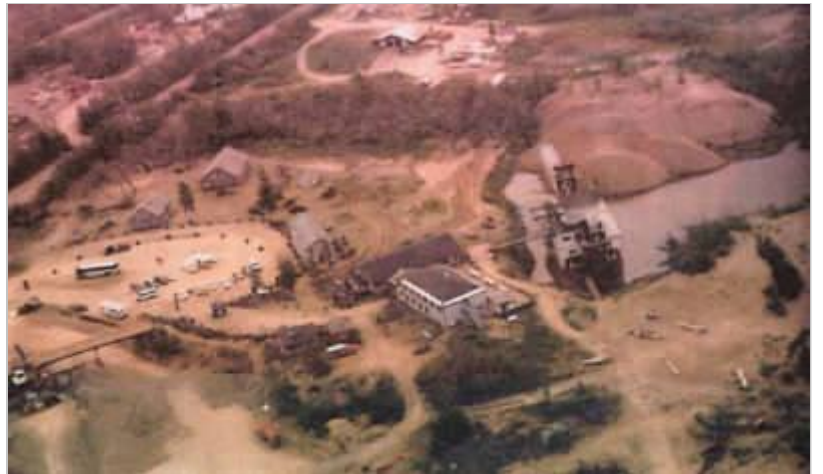
Catwalk photo indicating location in oblique 1987 aerial (shown lower left below) used to scale first draft exhibit of conveyors.

Since the evidentiary hearing was coming up in September, I made a draft pretrial exhibit with these derived dimensions of the plant footprint and conveyor arms. I noted on the draft that these were informational only as we were awaiting drawings from the Anchorage firm of Quantum Spatial, Inc., owners of the aerial images from 1984 to 2002.

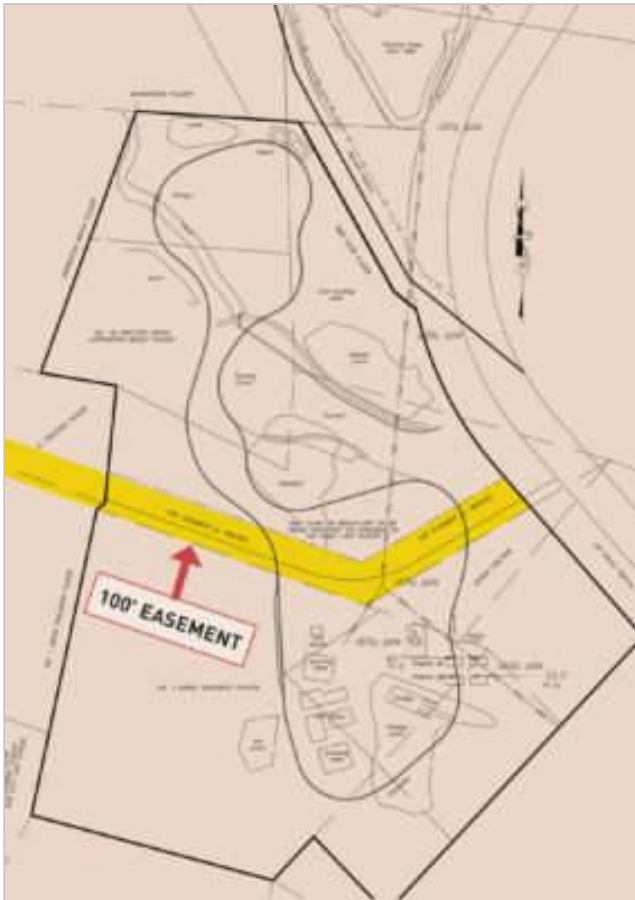
Original survey plat of Gold Dredge #8 camp for Godspeed, LLC showing narrow gauge tourist train tracks crossing 100' access easement proposed to be dedicated with 60' ROW for Landfill Road.

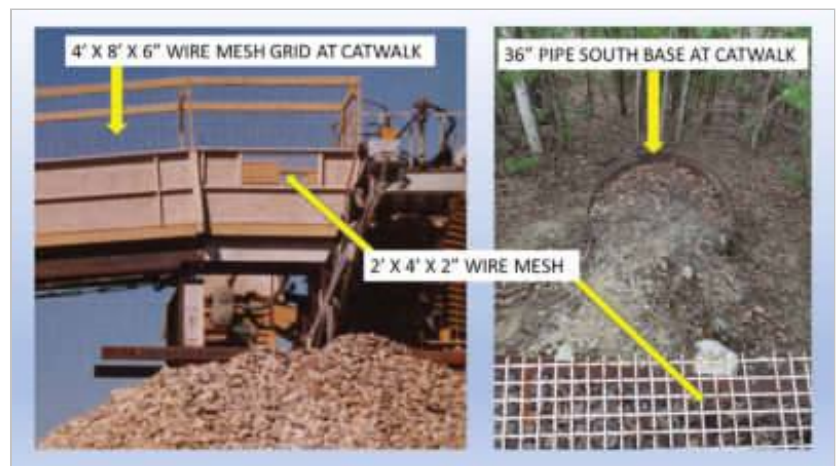
Wire mesh grids from catwalk and base used to scale dimensions in photos.

I recovered two of the steel lattices where the catwalk base was still located. They measured at 4' x 8' with a 6" mesh (used as reinforcement in concrete slabs) and the smaller 2' x 4' with a 2" mesh (used as screens for sifting the gavel). Using these as basically grid paper on the photos and videos I was able to determine the rough dimensions of the plant, catwalk, and conveyors.

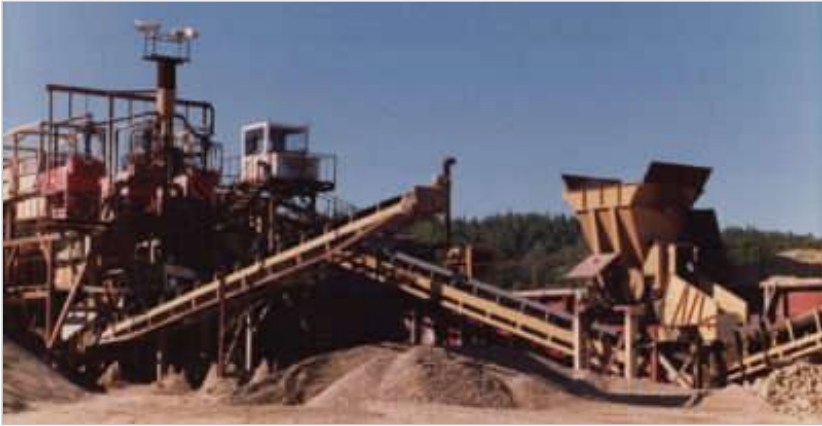
Gold plant control cab with hopper feed conveyor for raw gravel and one of four adjacent discharge conveyors. Photos courtesy of Alice Ellingson
