Decision to Identify and Accept Chitina Cemetery Road RST #_____

As a RS 2477 Right of Way 43 U.S.C. §932

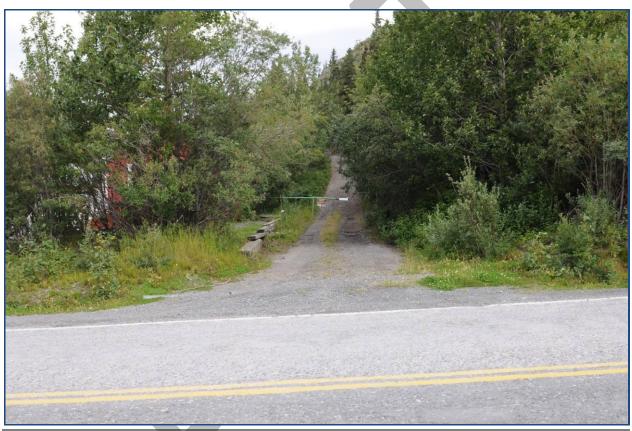
Figure 1: Chitina Cemetery Road center, McCarthy Road in foreground and Bunkhouse to left
Photograph by Kevin Sorensen, DNR PAAD Unit, August 12, 2010

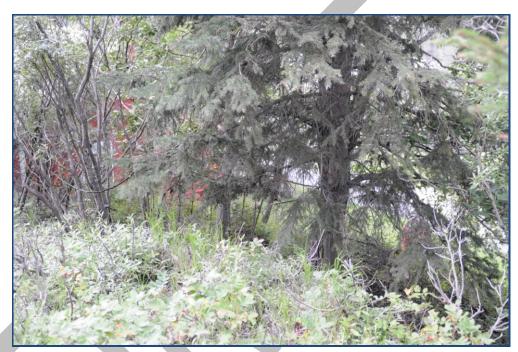
RESPONSE: The portion of the road currently by the bunkhouse was constructed no later than September 1910 by a mechanized blade cut. The cutback into the hill is still obvious after one hundred years. It appears the overburden was casted to the downhill side of the roadway. Some of that overburden formed an earthen berm on the downhill side of the roadway. This berm appears to be in place beginning about where the bunkhouse ends and continuing to the residential dwellings on Lots 8 and 9 of Block 6. It ranges from about two feet to five feet high except for a portion about midway. The roadway is largely resting on undisturbed soils. The slope and berm are heavily vegetated including mature trees.

There is no evidence that the integrity of the road prism¹ has a reasonable likelihood of failure in such a way as to roll a vehicle into the bunkhouse. To the contrary the road appears to be very stable for its historic uses. The bunkhouse is approximately fourteen feet (in the front) to seventeen feet (in the back) from the edge of the roadway. The slope in that section appears stable at approximately a 3 to 1 slope. The front end of the bunkhouse is at approximately the same grade as the roadway and the back is approximately six feet below the roadway.

It does not seem likely that this section of road that has been stable for one hundred years would fail to the point that from a six-foot elevation it would roll a vehicle through the trees and onto a structure seventeen feet away.

Figure 10: Photograph by Kevin Sorensen, DNR PAAD Unit, August 12, 2010. The red building is the bunkhouse.

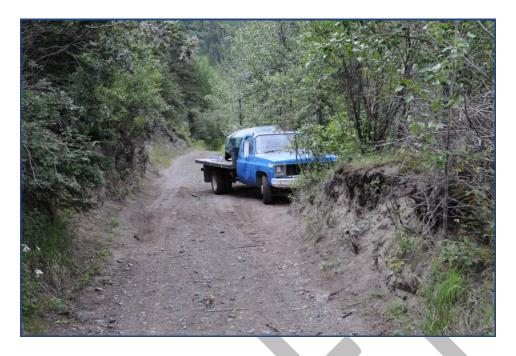
RESPONSE: The road has been in place and in use since 1910. The road is visibly obvious even in the old low quality old photos. There is no known reason to think that any owner or potential owner of the bunkhouse would not have known the road was there and that there was a cemetery at the end of it. The railroad constructed the buildings several years after the road and cemetery were constructed and put in use. The owners purchased and developed the property with their eyes open to whatever risk the road may pose to their business and accepted that risk. Further, this owner drives and parks a heavy water tank truck in this roadway directly above the large cache.

Figure 11: Photograph taken by Kevin Sorensen, DNR PAAD Unit, August 12, 2010. The truck is parked above the large cache.

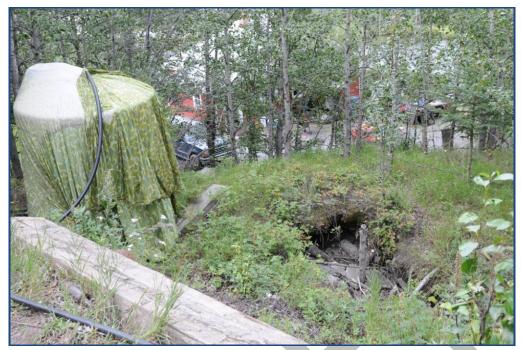
Figure 12: Photograph by Kevin Sorensen, DNR PAAD Unit, August 12, 2010. Photo taken from the off the roadway. To the left is the water tank. The red building in the background is the Mess Hall and the hole is the collapsed roof of the cache filled with debris.

The smaller cache has not collapsed, but because of obvious deterioration it is not deemed safe to enter. The nearest portion of the small cache to the roadway is eleven feet. The soils between the cache and the roadway appear on visual inspection to be stable. The caches and the road have coexisted for almost one hundred years and there is no evidence that the road has had a structural adverse affect on the caches. In addition the historic use of the road to access residences and the cemetery pre-date all the historic buildings in question.

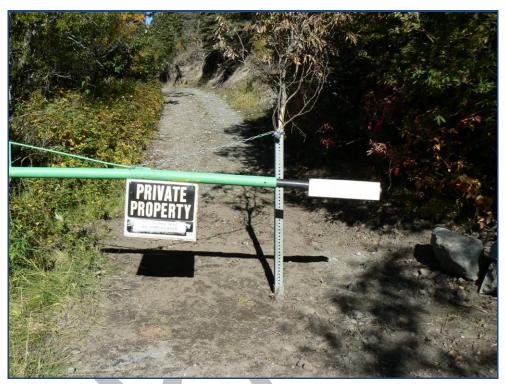
Figure 15: Photograph by David W. Schade, DNR PAAD Unit, September 16, 2010. The road is currently blocked so that only a pedestrian could use the road and prosecution for trespass is threatened.

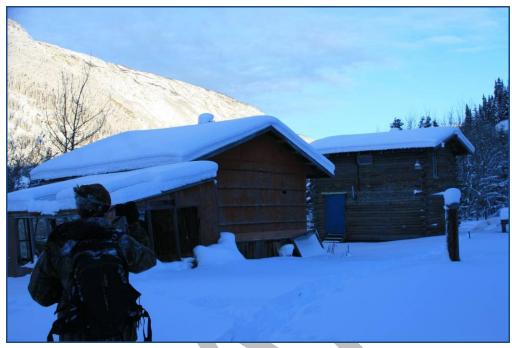
Figure 16: Photograph by Kevin Sorensen, DNR PAAD Unit, January 21, 2010. Jason Cheney, ADF&G in foreground. Photo of the residential structures on Ammi property, Lots 8-10, Block 6.

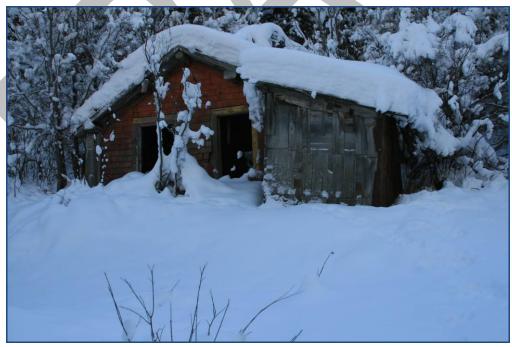
Figure 17: Photograph by Kevin Sorensen, DNR PAAD Unit, January 21, 2010. This abandon dwelling appears to be in the vicinity of the easterly common lot corner to Lots 7 and 8 Block 6. When it was constructed and when it was abandoned are not known at the time of this report.

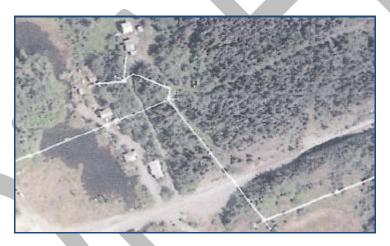
RESPONSE: This is visibly confirmed by photos taken on site visit January 21, 2010 and again August 12, 2010. There are two electric poles along the road were the road makes its first turn just before the Ammi residence. The electric distribution lines come from the east, then turn to the north roughly paralleling the cemetery road, and then turn west towards Chitina. The Chitina Cemetery Road appears to be the only service access to the electric distribution lines.

Figure 18: White lines delineate the overhead electric lines. Photo curtesy of Judy Block. Origin is unknown. Note the residential structures where the road bends after climbing the hill. These would be the Ammi property.

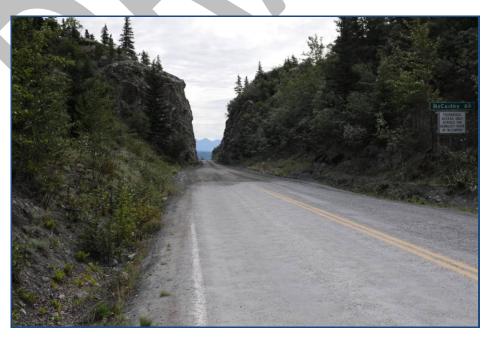
It is possible to adjust the alignment of an RS 2477 right of way. However, in this case the topography and economics of the area at this time make that option unfeasible. An inspection of the area indicates that the builders of the road looked at the conditions on the ground and built the road in the logical place. The designer of the townsite was probably looking at the top of his desk in his New York office when he designed the Chitina Townsite.

Figure 19: Photograph by Kevin Sorensen, DNR PAD Unit, August 12, 2010. Taken from where the Chitina Cemetery Road starts and looking east up the McCarthy Road. The Chitina Townsite is to the left. There are four platted rights of way that are perpendicular to the McCarthy Road in this view.

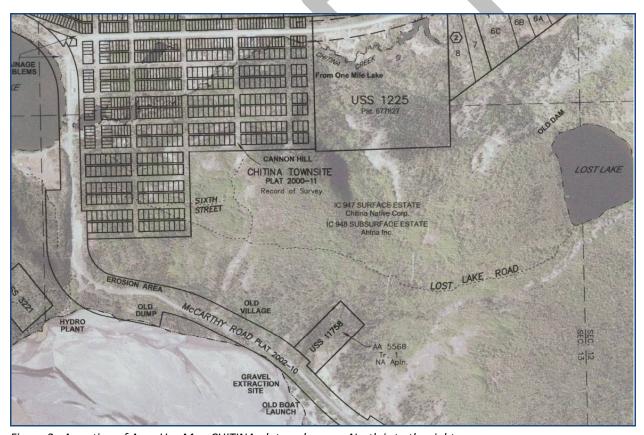
Figure 2: A portion of <u>Area Use Map CHITINA</u>, date unknown. North is to the right.

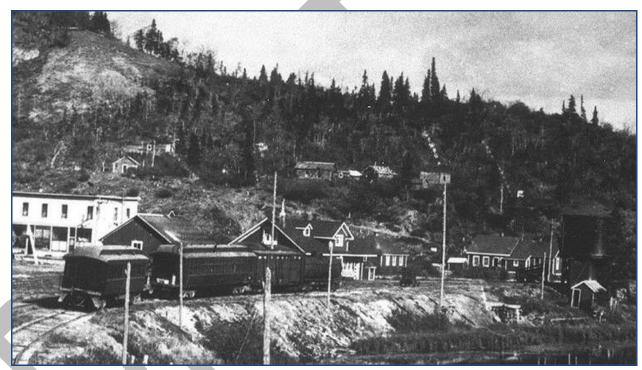
Figure 7: Photograph taken between 1912 and 1919 shows depot is in foreground, Chitina Hotel to the left, bunkhouse to the right, Chitina Cemetery Road in center and residential dwellings above. Photo curtesy of Judy Block, origin unknown.

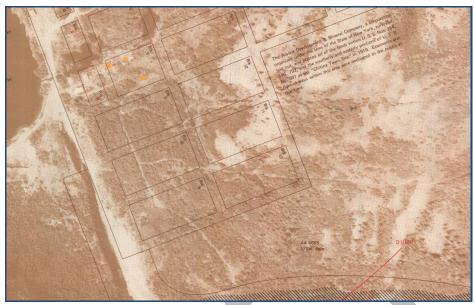
Figure 8: A portion of 1974 aerial photograph with the rights of way and blocks of Chitina Townsite overlain. Taken from <u>Community Map</u>, prepared by Arctic Environmental Information and Data Center, University of Alaska, 1977.

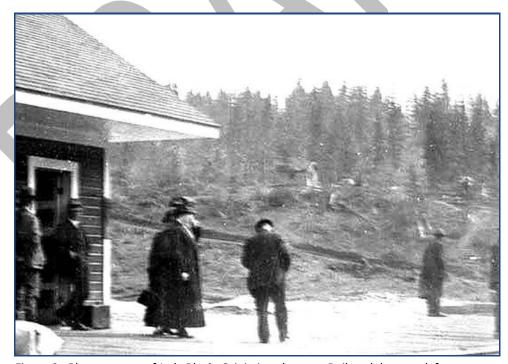
Figure 9: Photo curtesy of Judy Block. Origin is unknown. Railroad depot at left was constructed after the Chitina Cemetery Road was constructed according to other photography. A photo dated March 1, 1912 has depot and road, but not bunkhouse. Note: residence on hill

16.) The Chitina Cemetery Road was constructed before the Copper River & Northwestern Railway bunkhouse was constructed.
